Note: This is an excerpt from the Dry Cask Storage: Defense-In-Depth presentation provided during the SONGS Community Engagement Panel meeting on August 17, 2023. The full presentation and video are available [here](#).

SCE Addresses Questions Regarding Recommendations by Lucius Pitkin, Inc. for SONGS Holtec Storage System

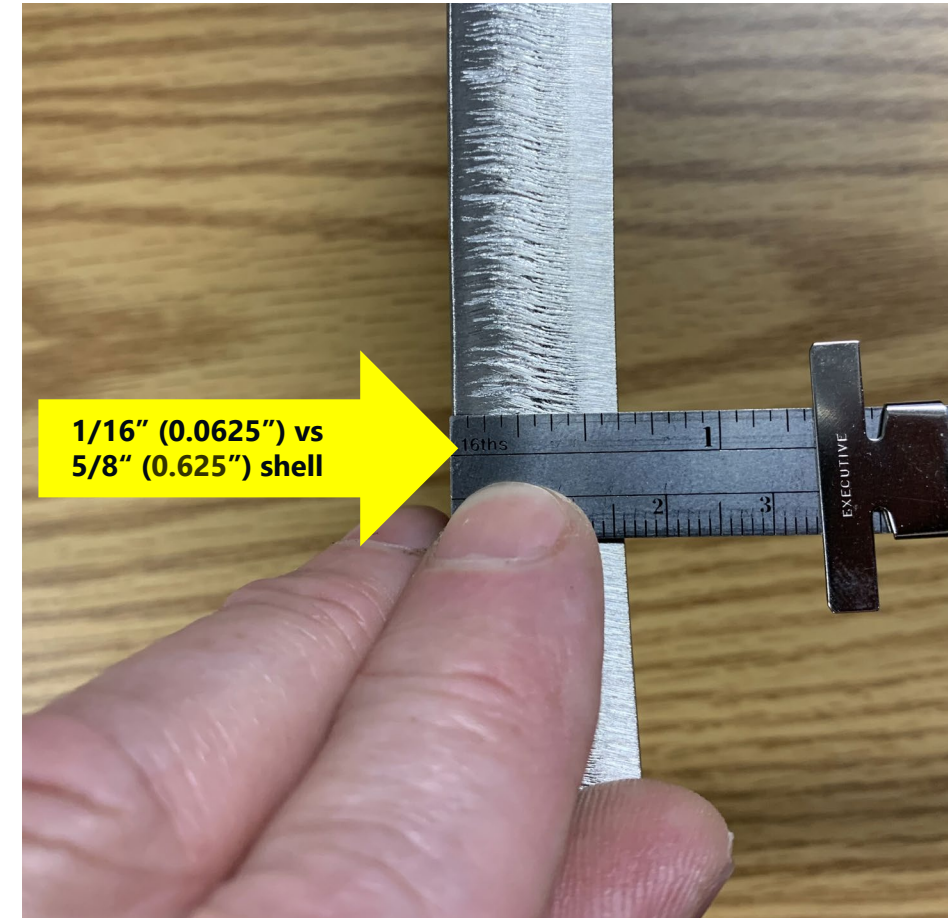
1. *The IMP should include a flaw depth of 0.0625" (1/16") as the threshold for fuel canister repairs such that flaws deeper than 0.0625" would be repaired:*

- 90% of the shell wall remains at a 0.0625" (1/16") threshold; 0.0625" represents 10% of the 0.625" (5/8") thick shell
- Nominal shell thickness is 0.5" (1/2"); therefore, ASME¹ code allowance would be 0.45" (10% reduction in wall thickness)
- SCE specified an additional 1/8" shell thickness to the nominal design for a total of 5/8"; therefore, SCE's position is up to 0.175" is allowable ($0.625" - 0.450" = 0.175"$)

1. *(continued) The IMP should include a flaw depth of 0.0625 as the threshold for fuel canister repairs. Flaws deeper than 0.0625 inches would be repaired:*
 - Lucius Pitkin notes limiting flaw depth to 0.0625" ensures a flaw will not penetrate the 0.080" (minimum) deep compressive residual stress provided by laser peening of the weld areas
 - Chloride induced stress corrosion cracking (CISCC) cannot occur if tensile stress is not present—i.e., cannot occur within the 0.080" (minimum) deep compressive residual stress region
 - Therefore, SCE agreed with Lucius Pitkin's recommended 0.0625" threshold for canister repair
