June 15, 2018
0299-0042-LTR-004R2

Subject: SONGS Dry Used Fuel Storage and Chloride-Induced Stress Corrosion Cracking (CISCC)

WHITE PAPER

SONGS Used Fuel Management – Defense in Depth

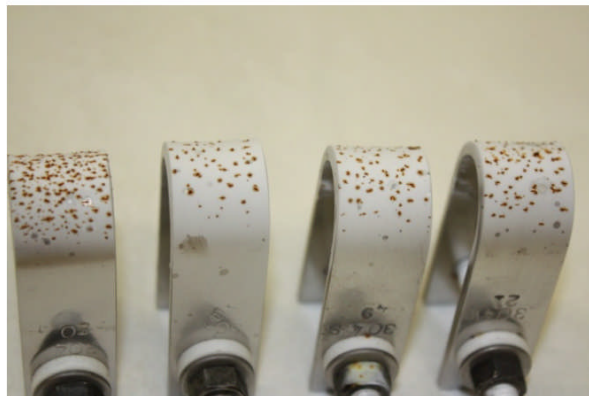
CISCC cracking in stainless steel is indicated by a preponderance of surface corrosion deposits in areas with high residual tensile stress, which for canisters are the vicinity of welds. General corrosion and pitting also produce surface corrosion deposits but these deposits are distributed evenly without regard to tensile stress. Surface corrosion deposits similar to those shown in Figure 3 below (Reference 12), that are concentrated in areas of high tensile stress (apex of U-bend specimen), indicate CISCC. If a preponderance of surface corrosion deposits in weld areas are observed on used fuel canisters additional testing would be required to determine if CISCC exists at these locations.

Figure 3. Surface Corrosion Deposits on CISCC U-Bend Specimens

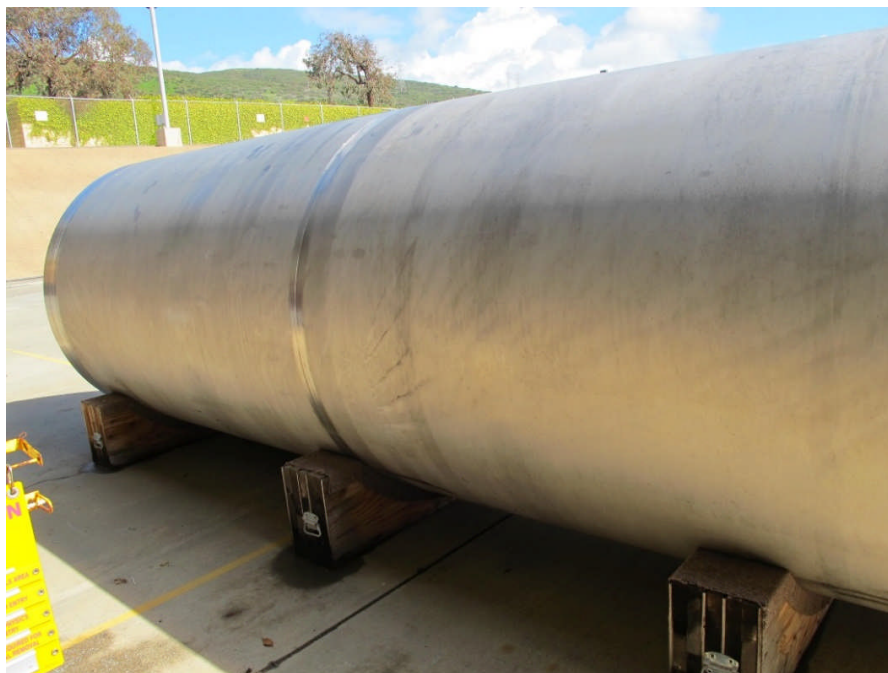
The welded stainless steel canisters used in the dry storage systems at SONGS provide a second barrier to release of radioactive materials. After the used fuel assemblies are loaded into a canister, water is removed and the canister is filled with helium gas and welded closed. The SONGS canisters provide a 5/8 inch (16 mm) thick, all welded, highly corrosion resistant stainless steel containment barrier around the used fuel assemblies. The helium gas placed inside the canister provides a chemically inert atmosphere which eliminates the potential for corrosion due to a moist air environment. The effectiveness of the canister as a second barrier is significantly enhanced by the absence of water inside the canister since there is no water available to transport soluble radioactive fission products out of a defect in a fuel rod. A SONGS used fuel canister is shown in the figure below.

Figure 4. Used Fuel Canister at SONGS

Used fuel canisters at SONGS contain 24 or 37 fuel assemblies. Canisters are welded shut and provide a second layer of defense-in-depth to help prevent the release of radioactive material. To minimize the risk of chloride induced stress corrosion cracking, canisters at SONGS are fabricated from 316L stainless steel, which is highly corrosion resistant.

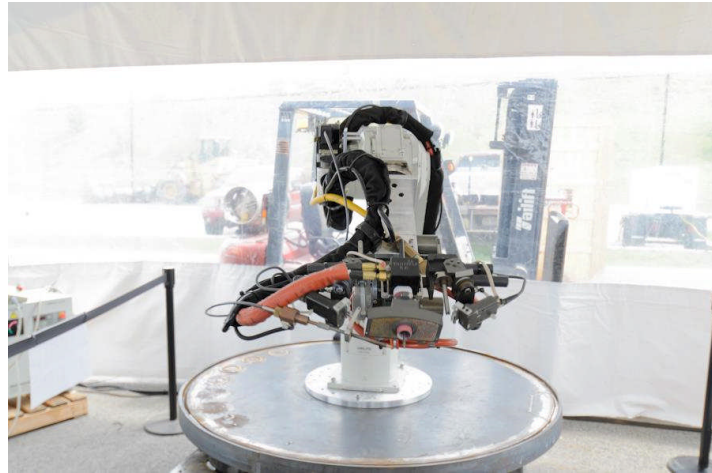
developed using the same basic techniques if needed. An example of remote welding equipment developed by Westinghouse for remote welding of used fuel canisters is shown in the figure below:

Figure 7. Westinghouse Remote Used Fuel Canister Welding Machine

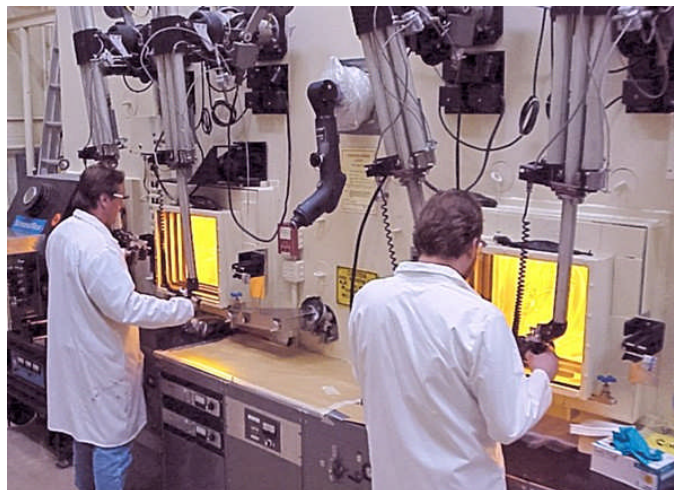
Transport casks have been used to ship severely damaged fuel, such as fuel from Three Mile Island, to shielded “hot cell” facilities at DOE National Laboratories (Reference 20). The DOE recently identified existing hot cell facilities on the Idaho National Laboratory (Reference 21) that could be used to open and sample used fuel canisters and then to repackage used fuel retrieved from the cask. A “hot cell” is a facility with thick (3 feet or more) walls that provide enough shielding to protect workers from the radiation emitted by used fuel assemblies. Shielded lead glass windows and remote handling devices allow workers to cut, weld and perform detailed examinations on used fuel in a dry environment inside the hot cell as shown in the Figure 9 below. Hot cell facilities have been used for nuclear research and development for over 60 years.

Figure 9. Hot Cell Facility at BWXT (Reference 22)
