CA Coastal Commission report,
CDP 9-15-0228 Special Condition 7

LA192017-R-001 REV. 1

**INDEPENDENT THIRD-PARTY REVIEW OF SONGS' INSPECTION AND
MAINTENANCE PROGRAM FOR THE HOLTEC ON-SITE INDEPENDENT SPENT
FUEL STORAGE INSTALLATION**

JUNE 12, 2020

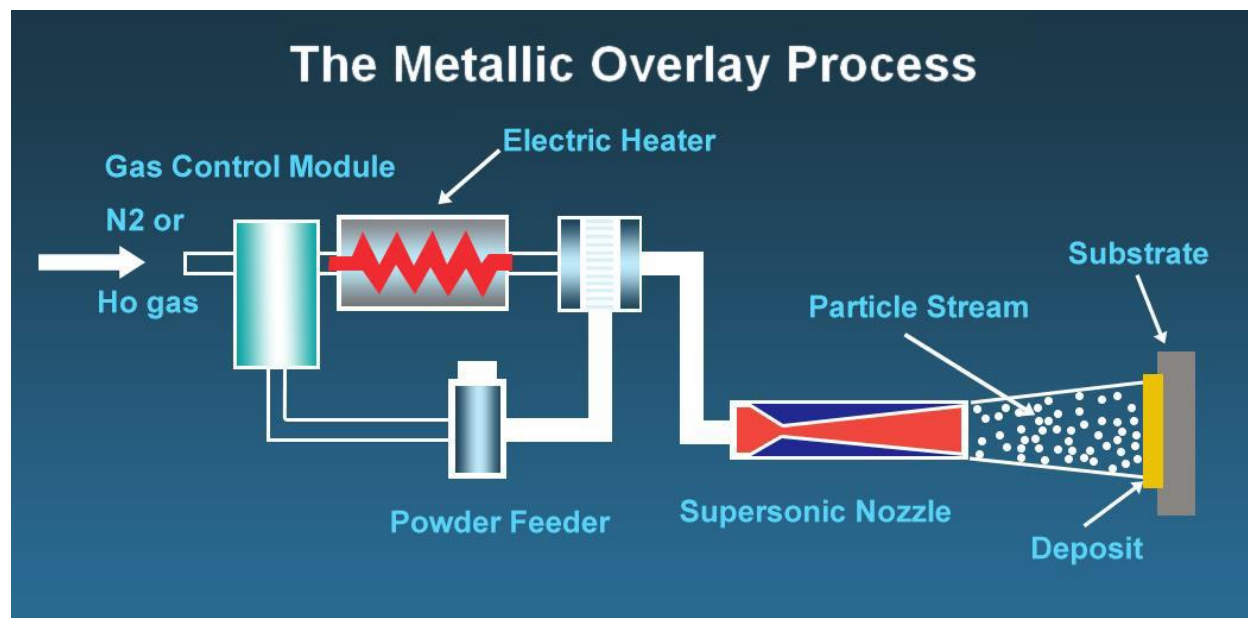
Figure 6-2 Metallic Overlay Process for Repairing MPCs at SONGS [1]

The metallic overlay process involves the application of a nickel coating to the damaged surface of an MPC. The metallic overlay process combines the capabilities of a robotic visual assessment with a high-energy solid-state coating and powder consolidation process involving an electrically heated high-pressure carrier gas (nitrogen or helium) to accelerate metallic powder through a supersonic nozzle above a critical velocity for particle adhesion (see Figure 6-2) [1, 25]. SCE and its partners developed and have demonstrated the capability to remotely apply a metallic overlay to mitigate a potential flaw in a canister. Remote inspection and canister mitigation procedures have been developed and approved by SCE [1].

LPI requested clarification on the potential for any adverse effects that result from the metallic overlay methodology, and how the overlay may affect the desired fabrication stresses of the MPC. SCE stated that laboratory tests do not show any adverse effects resulting from application of the metallic overlay process. Instead, the metallic overlay process induces a compressive stress on the base material, which improves the resistance to SCC initiation.

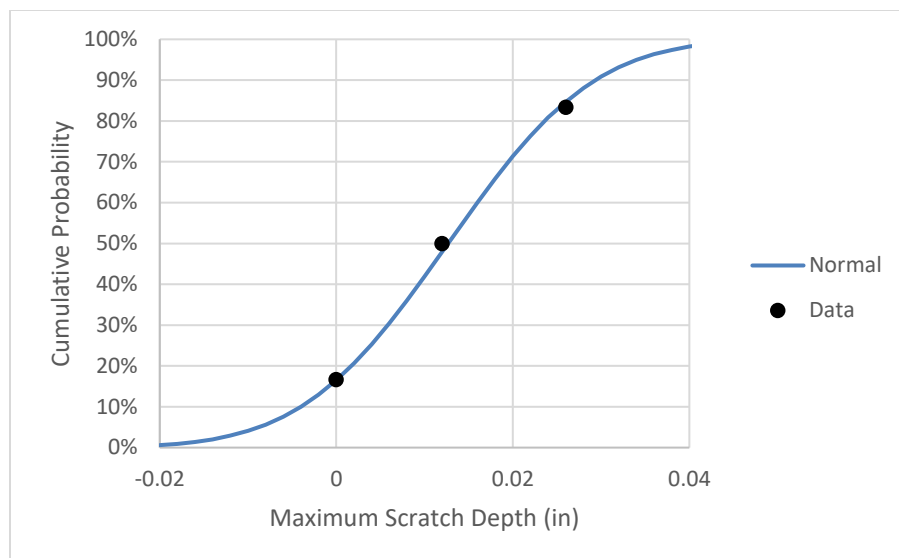
Figure 7-1 Normal Distribution, Three Wear Depth Measurements

LPI is of the opinion that the Normal distribution is not appropriate to model the maximum scratch depth per canister. In [29], the Normal distribution is based on the initial three measurements of 0.000, 0.012, and 0.026 in., with a corresponding mean and standard deviation (calculated by LPI) of 0.0127 in. and 0.013 in., respectively. In contrast, the Canister Inspection Plan [29] mistakenly reports the mean and standard deviation as 0.013 in. and 0.0125 in., respectively. This was clarified by SCE (as outlined in Attachment G) by conservatively replacing the reported 0.000 in. value with a 0.001 in. value to derive the mean and standard deviation values of 0.013 in. and 0.0125 in., respectively. An LPI plot of the data and fit are shown Figure 7-1.

For the initial three data points shown in Figure 7-1, it is evident that approximately 16.5 percent of the distribution extends into a region of negative or impossible values. If the mean and standard deviation for all 8 measurements had been used, approximately 7 percent of the distribution would still fall below zero. Both sets of data fail the typical “95% range check” [43] for considering the Normal distribution, whereby 95 percent of the fitted distribution needs to make physical sense. Although the primary region of concern is the upper tail of the distribution, specifically at 0.0625 in., having a significant amount of probability assigned to physically impossible negative values deprives the larger maximum scratch depths of probability, thereby underestimating the true risk to the canisters.

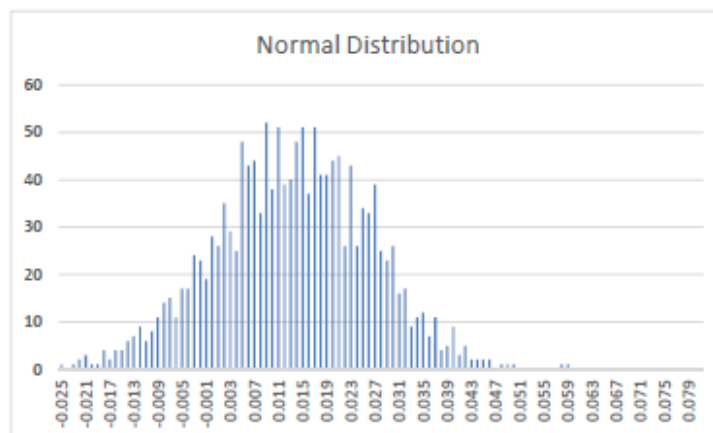
Figure 4-1.

One concern with selecting a normal distribution for modeling the deepest scratch random variable is that measured scratch depth is always a positive number and the left tail of the normal distribution will include some negative numbers making the probabilities associated with a standard normal distribution non-conservative. To determine whether use of a standard normal distribution is acceptable considering the effect of the negative left tail values, a simulation was run using 1500 trials to produce a modified normal distribution that forces all scratch depth measurements to be positive numbers. In the simulation, every time a negative value for scratch depth occurs, the simulation selected another normally distributed random number to replace the negative value until a positive value appeared. The results of simulations for the standard normal distribution and the modified normal distribution for the mean scratch depth (13 mils) and standard deviation (12.5 mils) associated with the three measured canisters are compared below.

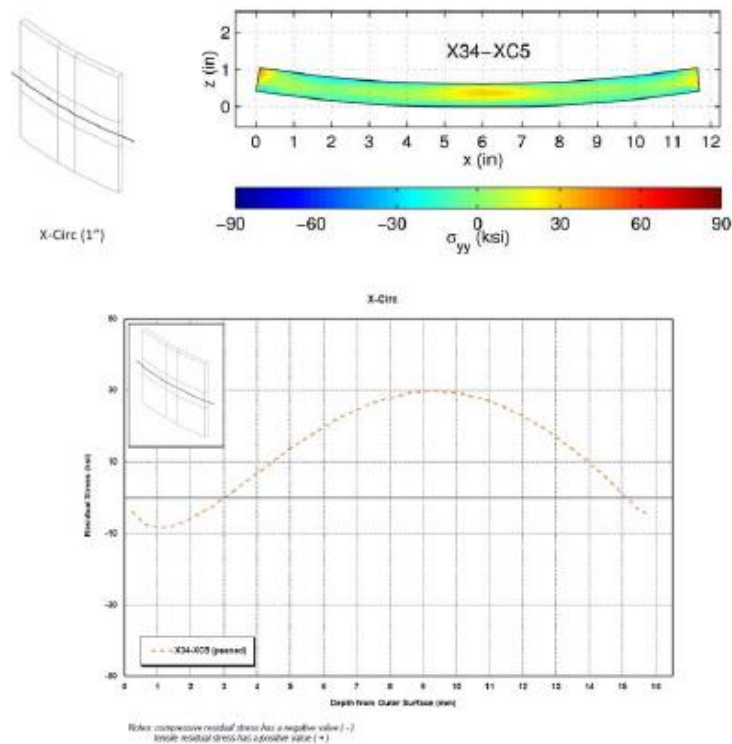
Values for residual stress for coupons are taken by performing an EDM cut through the weld centerline. The values for the plots are then taken from the center of the coupon contour profile. Coupon X34-XC5 will be used as an example. This coupon has an x-weld pattern which represents the longitudinal weld and circumferential weld at the middle of the canister. The EDM cut was performed along the weld centerline of the circumferential weld, shown as a bold line in the sketch to the left below. Data points used for the plot are taken starting from the outside surface of the coupon (Z of 0 in) and continue to the inside surface of the coupon (Z of 0.625 inches). Plots were converted to mm to demonstrate that the minimum required depth of compression referenced on the Table were achieved.

As for the request for stress profiles away from the centerline, SCE does not have that data. During the peening process development, SCE concluded that the centerline of the weld is the highest tensile stress and so stress profiles were only generated for that location.

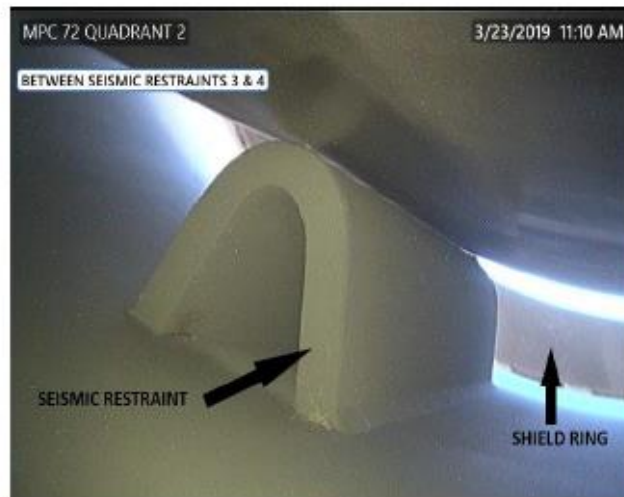
The seismic restraints are 304 stainless steel curved restraints (radius 2") that are part of the VVM interior to restrict MPC movement in the event of a seismic event during storage. Two sets of seismic restraints (one set near the bottom of the installed MPC, and one set near the top) are part of the VVM design. Interactions between the seismic restraints and the MPC resulted in scratches of up to most of the length of the canister, widths of up to 0.25", and depth of up to 0.026". Interactions with the seismic restraints were identified in 4 of the 8 MPCs inspected. The upper seismic restraint and shield ring are shown in Figure 1 below.

Figure 1. Robotic system photo taken from below the seismic restraint, looking up.

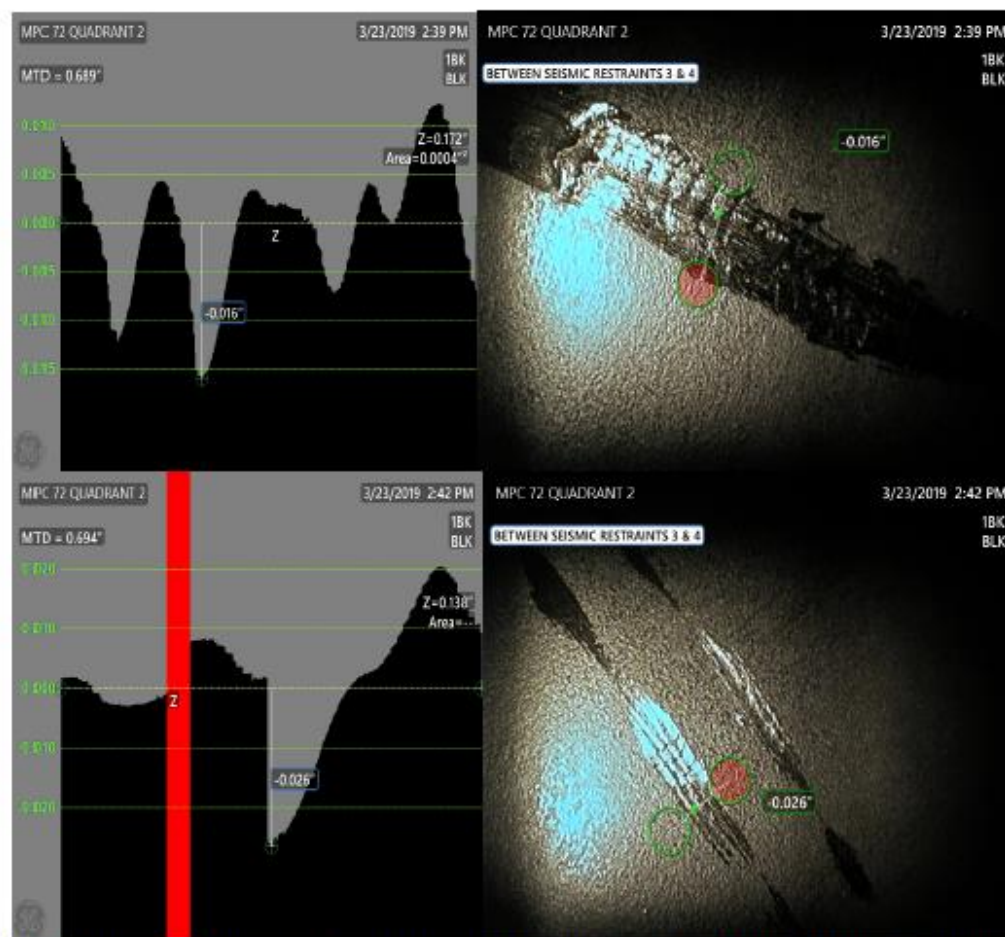
Figure 2 – Canister #72 Detailed Pictures and Profilometry

The deeper measurements were only observed in localized areas of galling. Galling occurs when two austenitic stainless steel surfaces wear, and is a different phenomenon than the scratching modeled by the FEA. Galling is self-arresting because the material is not removed, just rearranged.

(The red segment of the bottom left profilometry graph above represents 'noise' in the data that was not used for evaluation.)

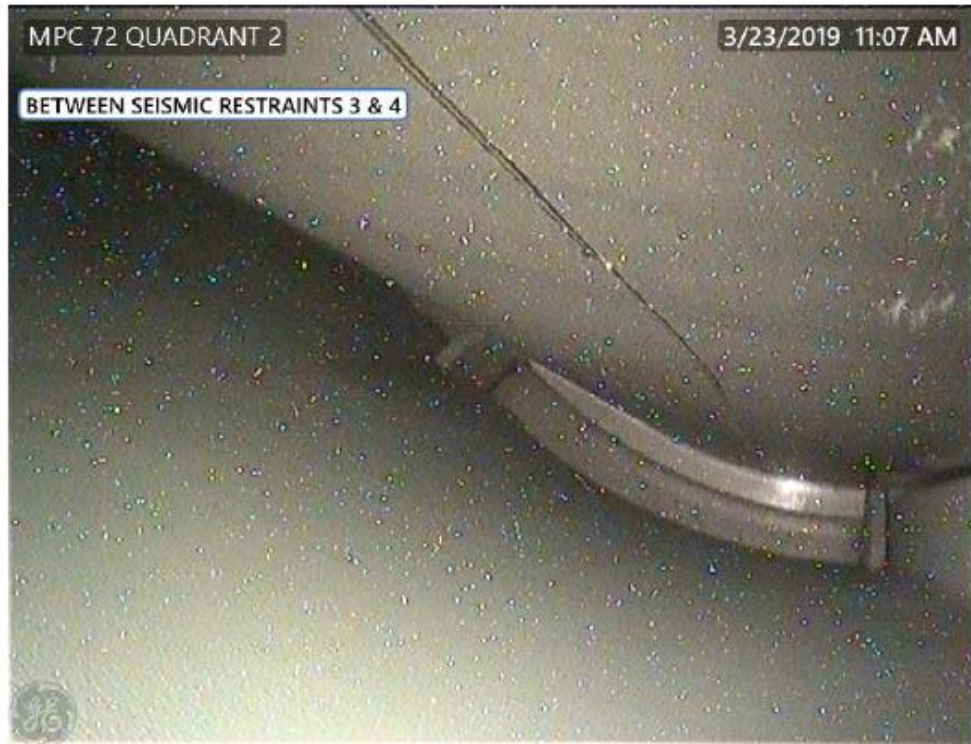
Figure 3. Photo showing a view of MPC 72 seismic restraint scratches.

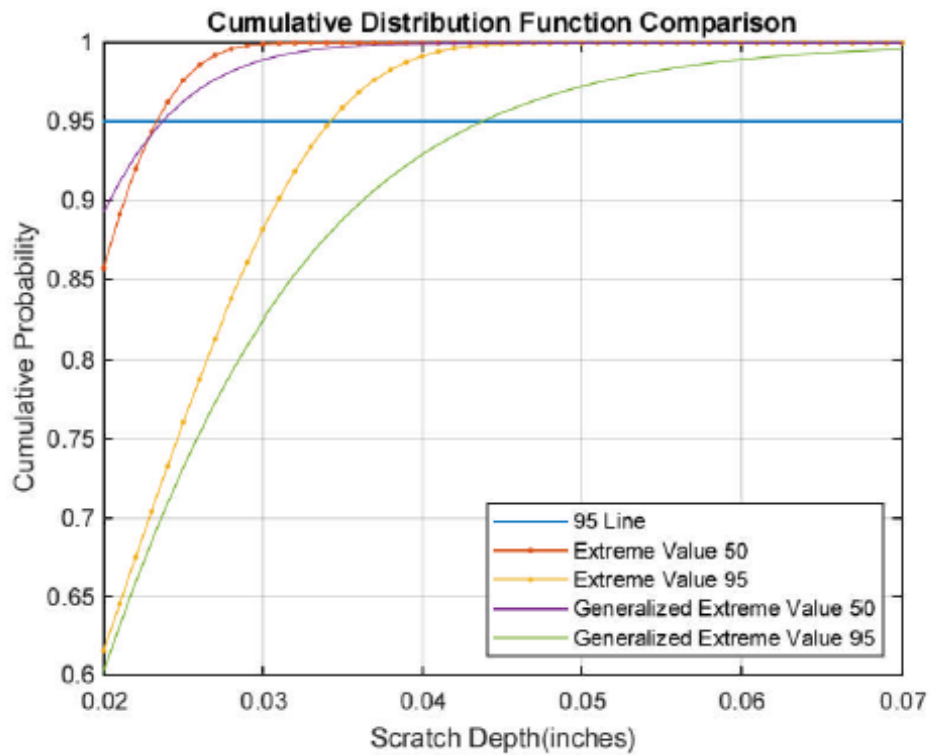
Figure 2-1. Extreme Value Cumulative Probability Distributions

The canister scratch depth data was fit to the extreme value probability distributions using MATLAB 2018a functions. As requested by the Coastal Commission, both the best estimate fit parameters (50 confidence) and the 95 confidence values of the fit parameters were used to generate cumulative probability distribution plots. The results are shown in the figure below.
