**SAN ONOFRE NUCLEAR GENERATING STATION (SONGS)  
SONGS MEAN SEA LEVEL RISE IMPACT ASSESSMENT**

**Technical Report for  
CSLC Special Provision 14 in Lease No. PRC 6785.1**

CE Reference No. 21-07  
25 March 2021

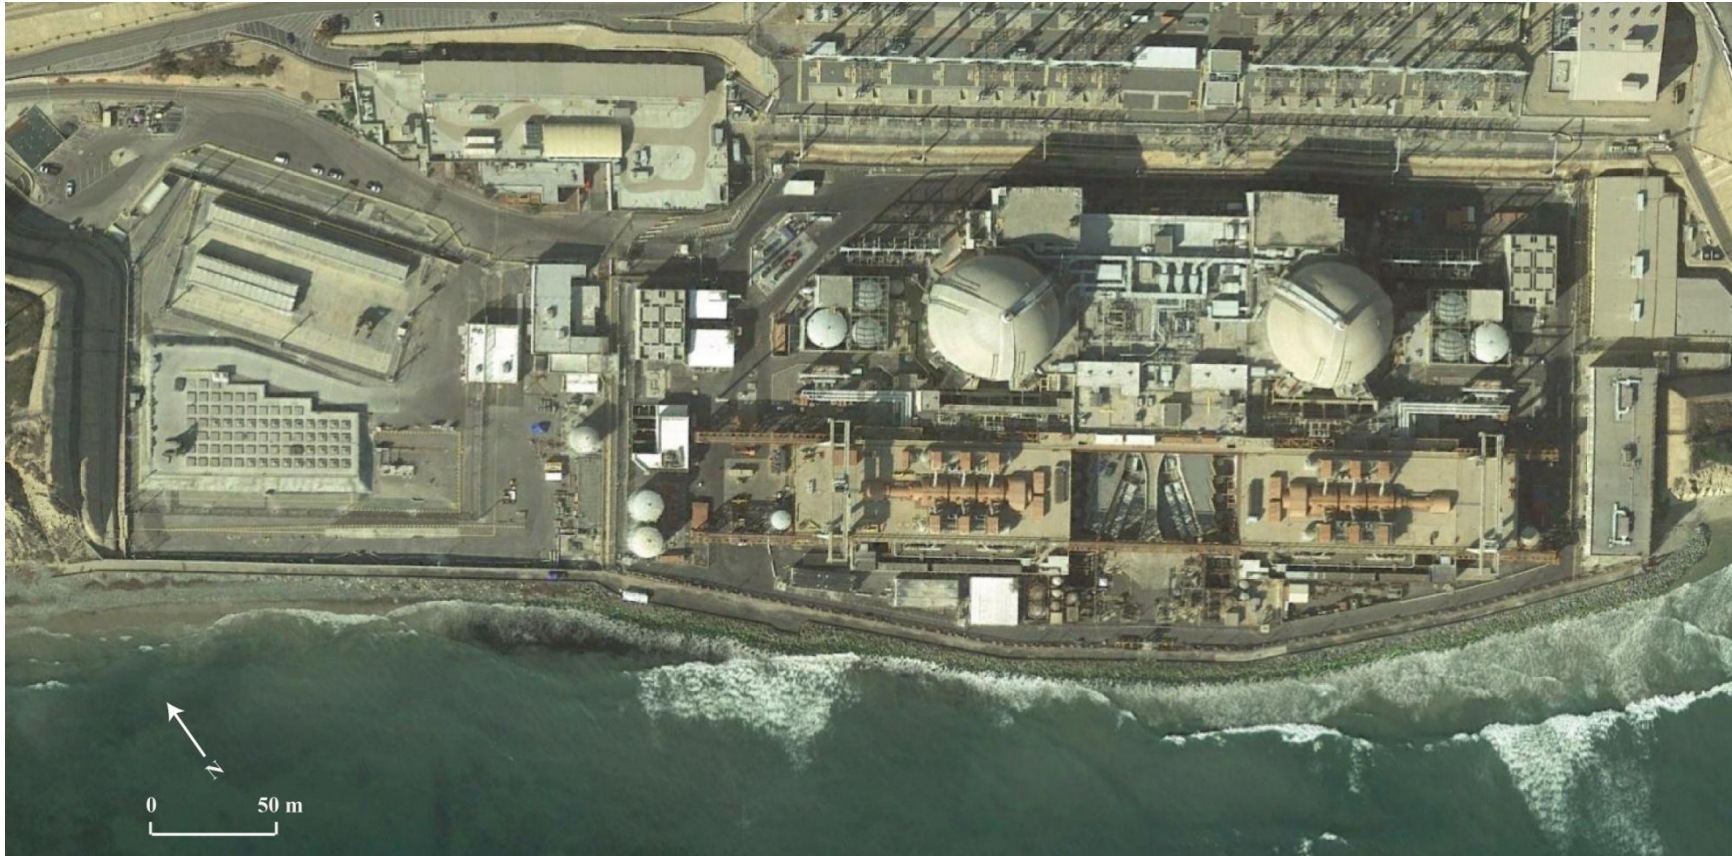
**Figure 3-1.** Photograph taken on 20 August 2018, showing the SONGS revetment. Notice the north part of the revetment is covered by beach sand.

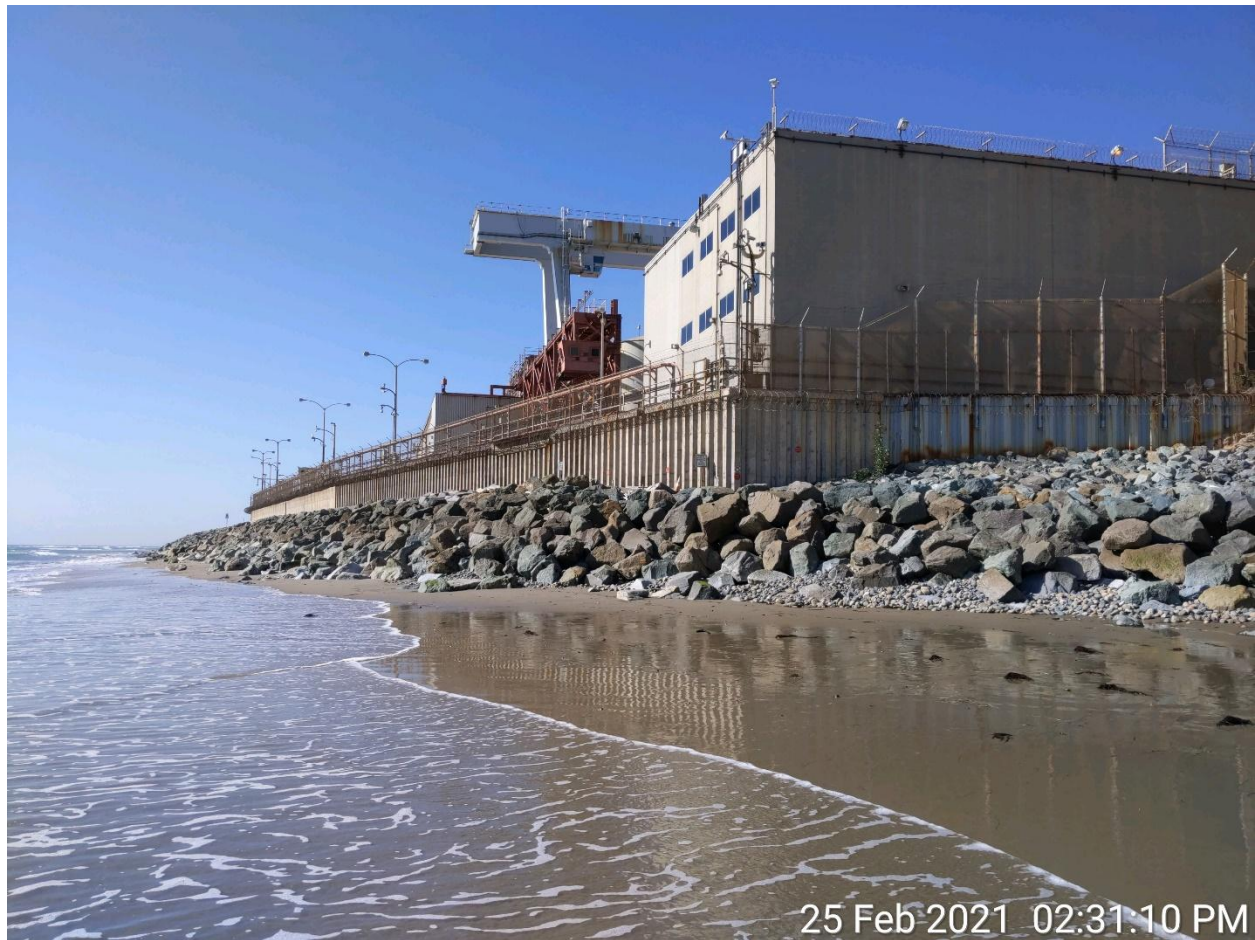
**Figure 3-2. The revetment at its southern end.**

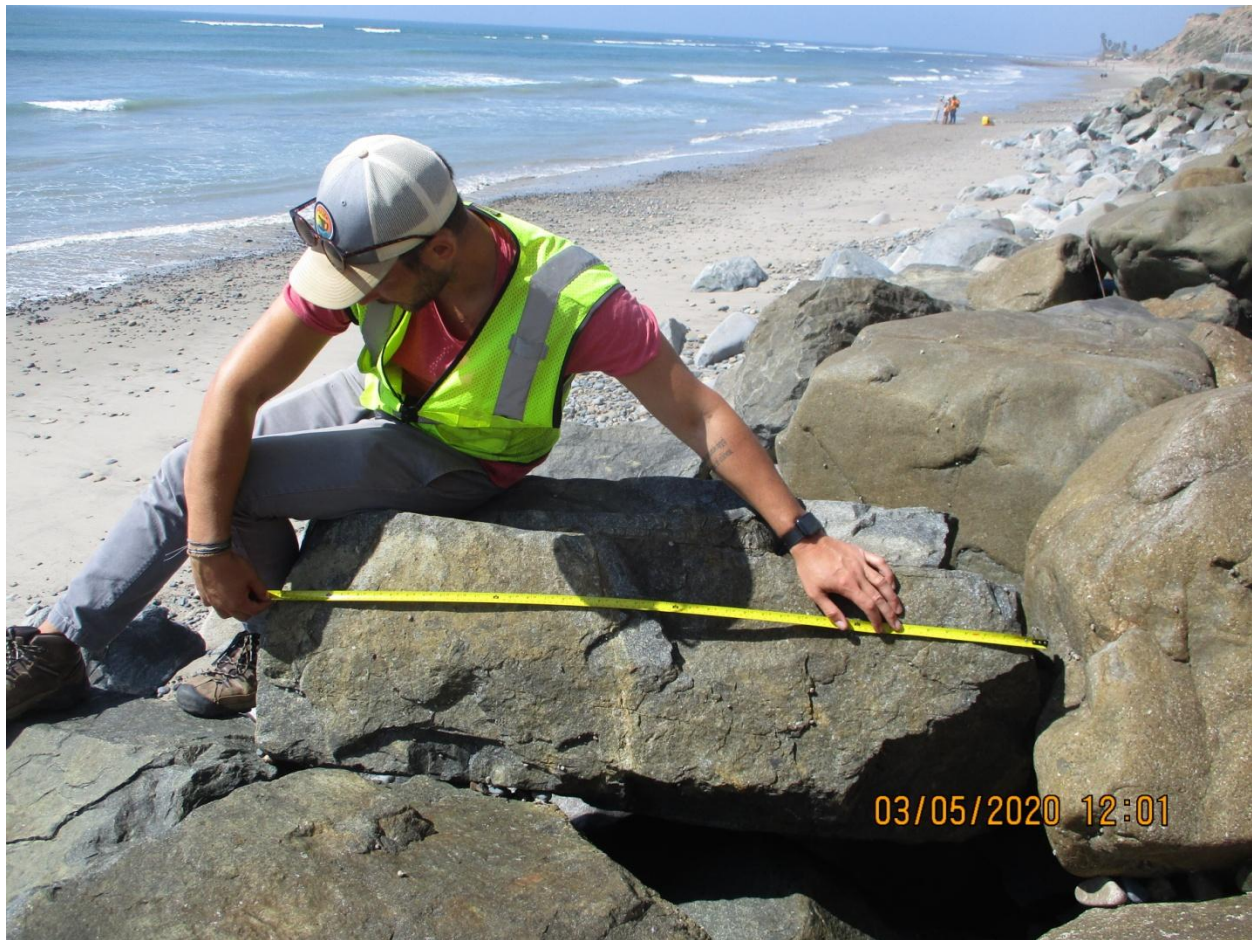
**Figure 3-5. Measurements of the long axis of the rock (length).**

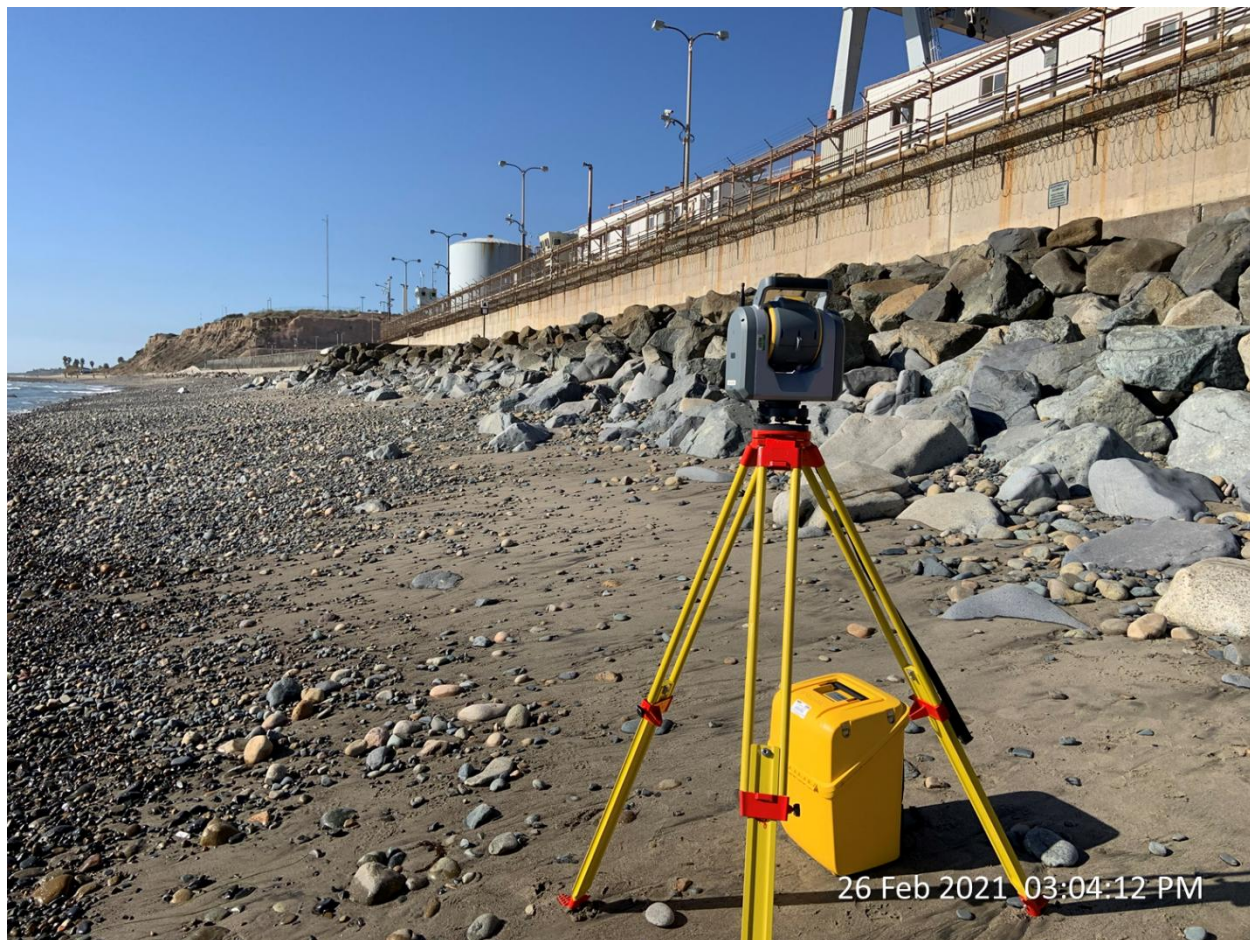
**Figure 3-8. Trimble SX10 scanning total station.**

A laser scanner survey was carried out using a Trimble SX10 scanning total station (Figure 3-8) for the purpose of creating a DEM to visualize the spatial characteristics of the revetment. Control points were established to aid in subsequent station setups. The revetment was scanned from the beach with scanner location determined from control points. The system scanned in a vertical direction and slowly rotated horizontally to cover the areas of the revetment at a high resolution. A total of 14 scans were carried out to capture the entire SONGS revetment.

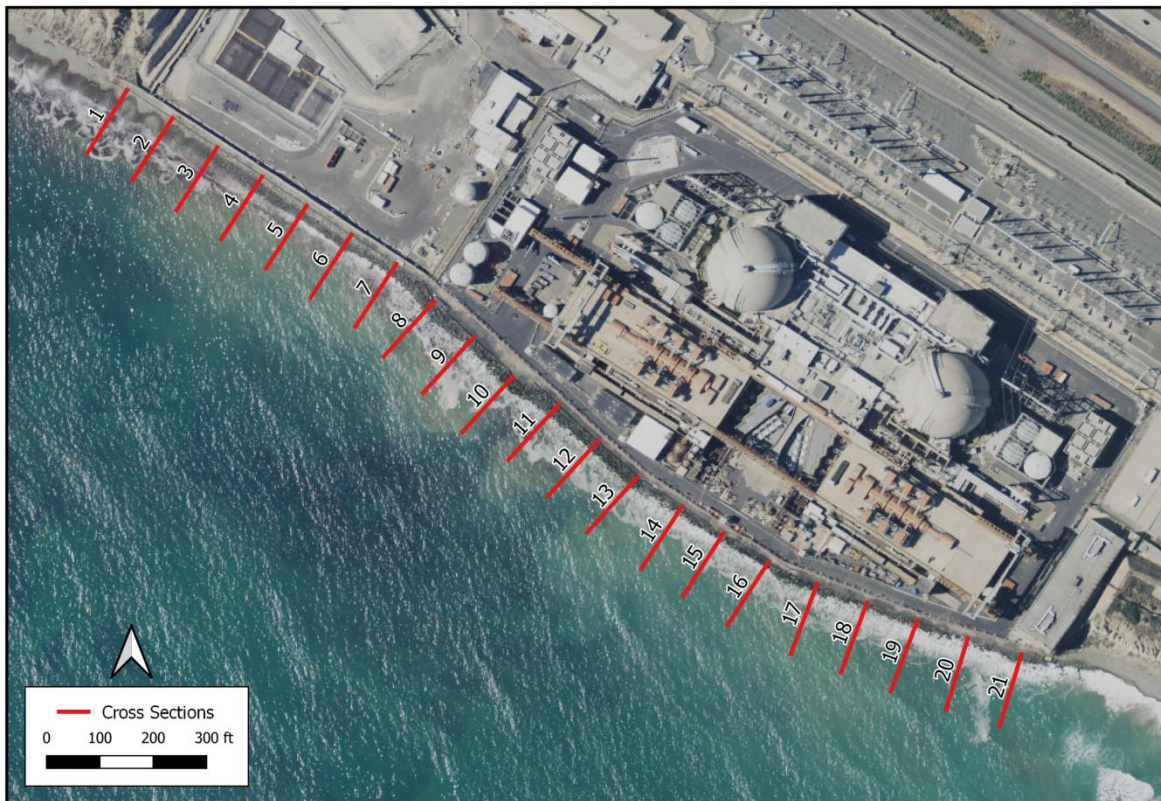
**Figure 3-9. Location of 21 transects along the revetment, spaced 100 ft apart.**

An advantage of creating a DEM is that the model can be “re-sampled” to show cross-sections and contour maps that would otherwise be difficult or impossible to derive in a reliable way. Twenty-one cross-section transects were generated from the DEM at locations shown in Figure 3-9. Results of the revetment laser scanner survey are shown in Figures 3-10 through 3-12 for the 21 transects. For clarity, Appendix A shows the DEM comparison between 2021 and 2020 for each transect. Representative cross-sections are shown in Figure 3-13; all 21 transect cross-sections are presented in Appendix B. Table 3-1 provides riprap height, walkway wall height, and the revetment slope  $\beta$  for each transect.

Figure 3-13 shows typical cross-sections of the SONGS revetment. The locations of these profiles are shown in Figure 3-9. The slope ( $\beta$ ) of the revetment varies from 0.33 to 0.44. The height of the walkway is about 14 ft (NGVD). The design water level is estimated as 5.5 ft (NGVD). Table 4-1 provides run-up and overtopping results for all design wave and water level conditions, including MSLR under the medium-high scenario for 2020, 2030, 2040, and 2050. Table 4-2 shows these results for the extreme H++ MSLR projection. Tables 4-1 and 4-2 suggest that wave overtopping already occurs (in 2020) for storm wave conditions meeting or exceeding a 10-year return period, that is, waves with 10% probability of occurrence in a given year. This is consistent with observations.

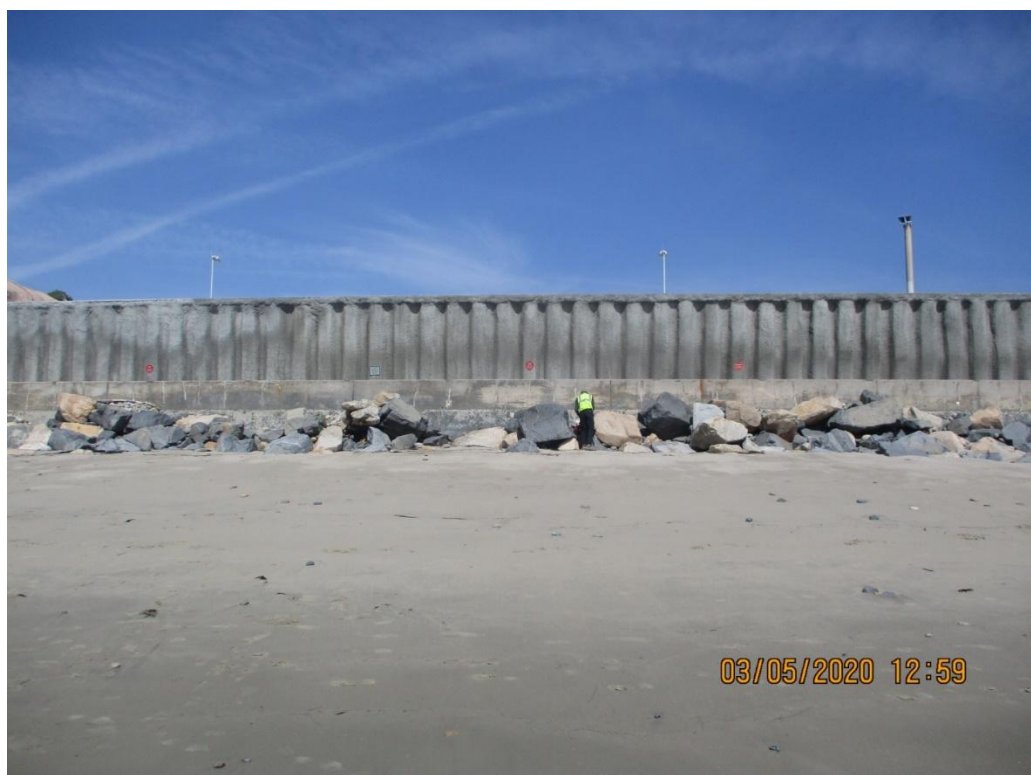
**Figure 3-24. North portion of the revetment covered by beach sand in 2020 (bottom), now covered with cobble in 2021 (top).**

In February 2020, the north portion of the revetment was covered by beach sand. Large waves in early 2021 removed this sand, exposing cobble and more of the revetment rocks under the sand (Figure 3-24). The changes in the San Onofre beach caused by the January and February

2021 large wave storms were normal and expected. They were typical of what has been observed at other Southern California beaches, such as Camp Pendleton, Oceanside, and the City of Del Mar.

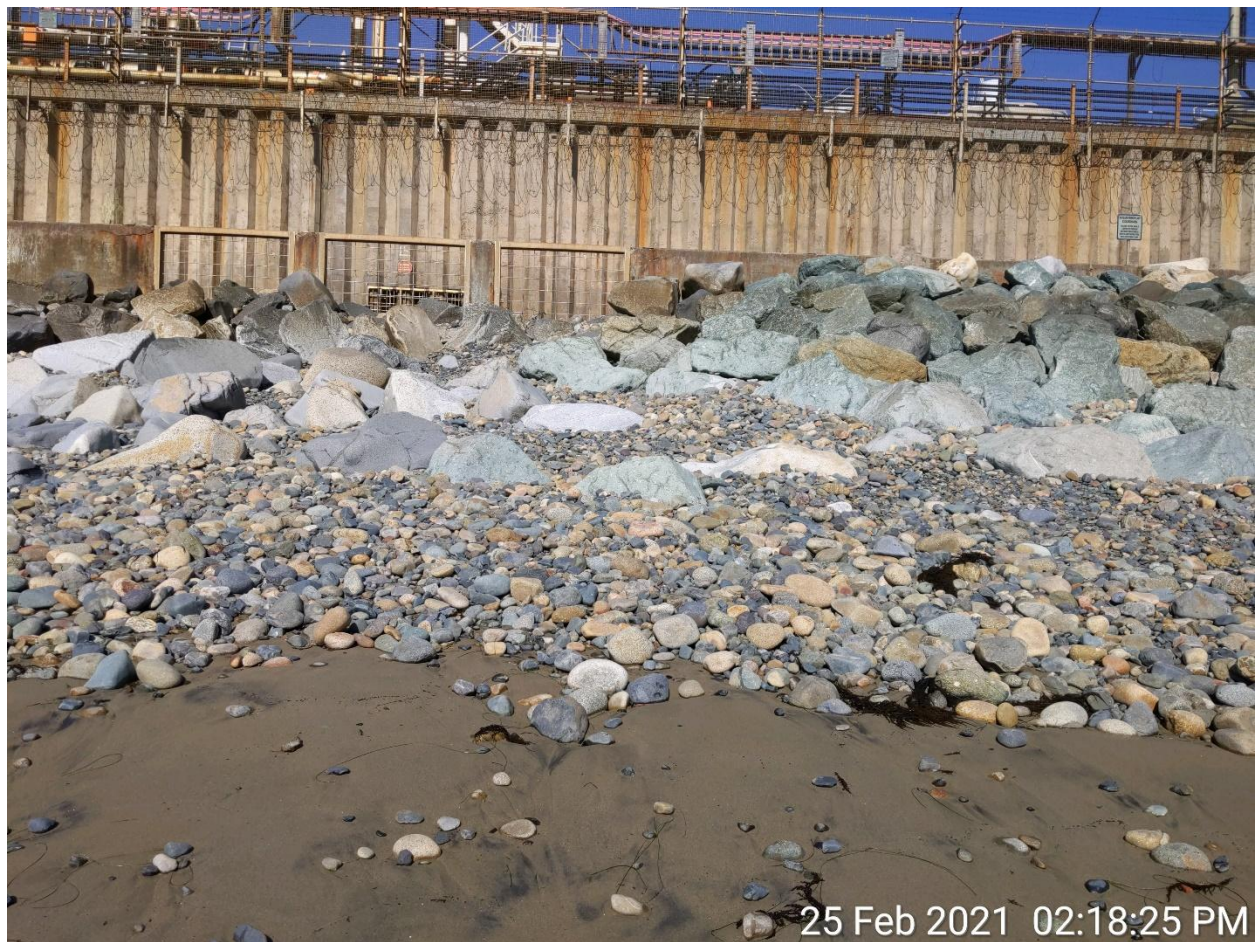
**Figure 4-2. Exposed area in the walkway wall.**

As MSLR progresses, overtopping rates are expected to increase. For large storms, rates are projected to reach 0.5 ft<sup>3</sup>/sec-ft by 2030 and 1-1.6 ft<sup>3</sup>/sec-ft by 2050. There is a short segment in the walkway where the concrete wall has been replaced by rails to provide a flow path for the saltwater cooling system during plant operations. This opening in the wall will increase overtopping on the walkway (Figure 4-2). However, it does not represent a significant hazard to pedestrians since the walkway will be closed during storms and there are no more discharges from the system.

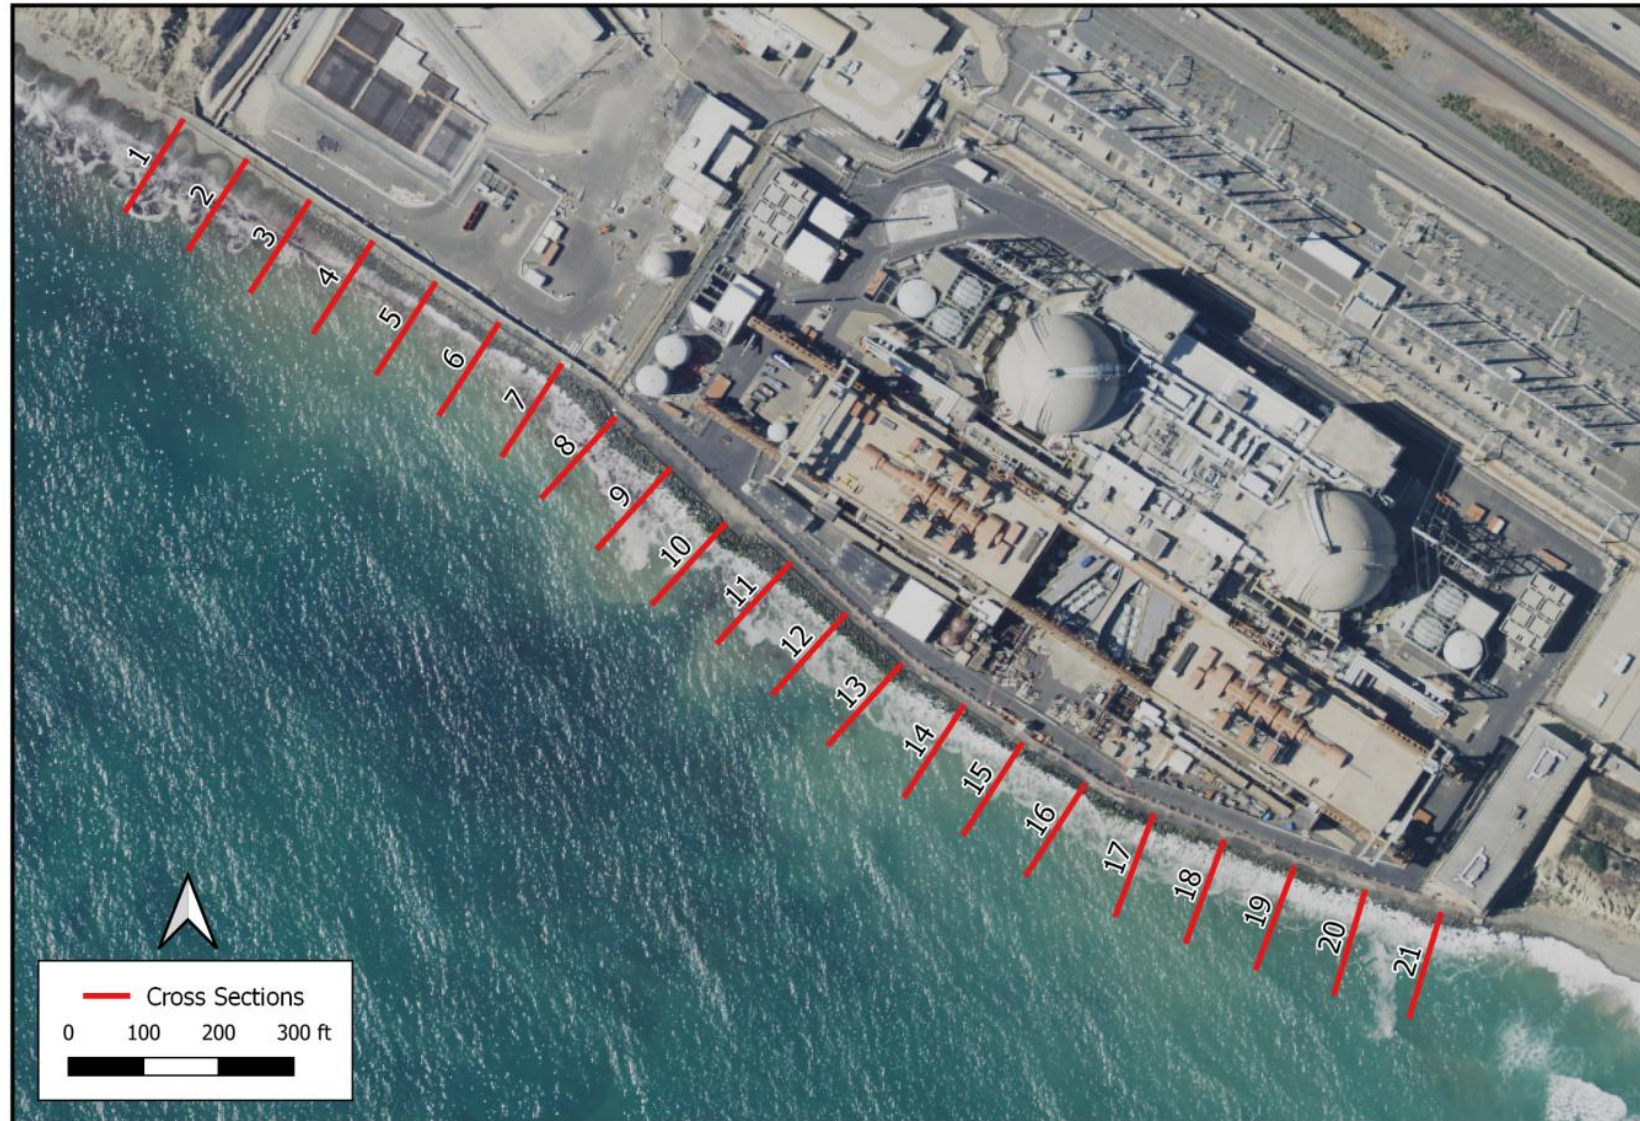
**Figure A-1. Locations of 21 transect ranges along the revetment, spaced 100 ft apart.**

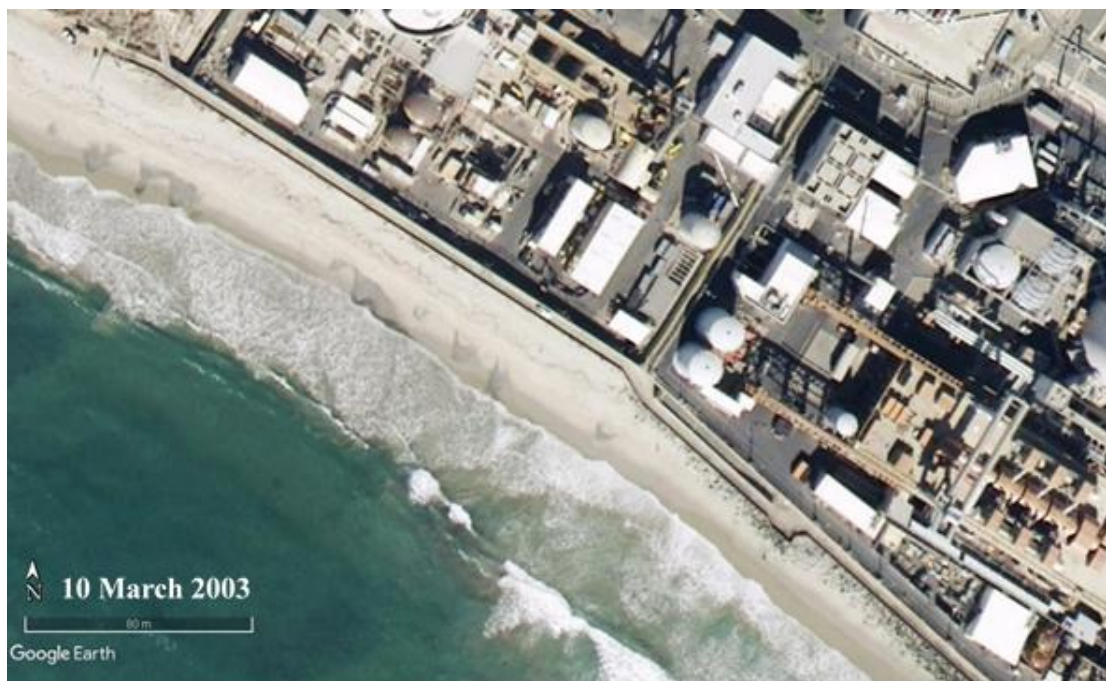
**Photo C-1. Photograph showing revetment covered by sand and fronted by a wide beach at the northern end of SONGS (10 March 2003).**

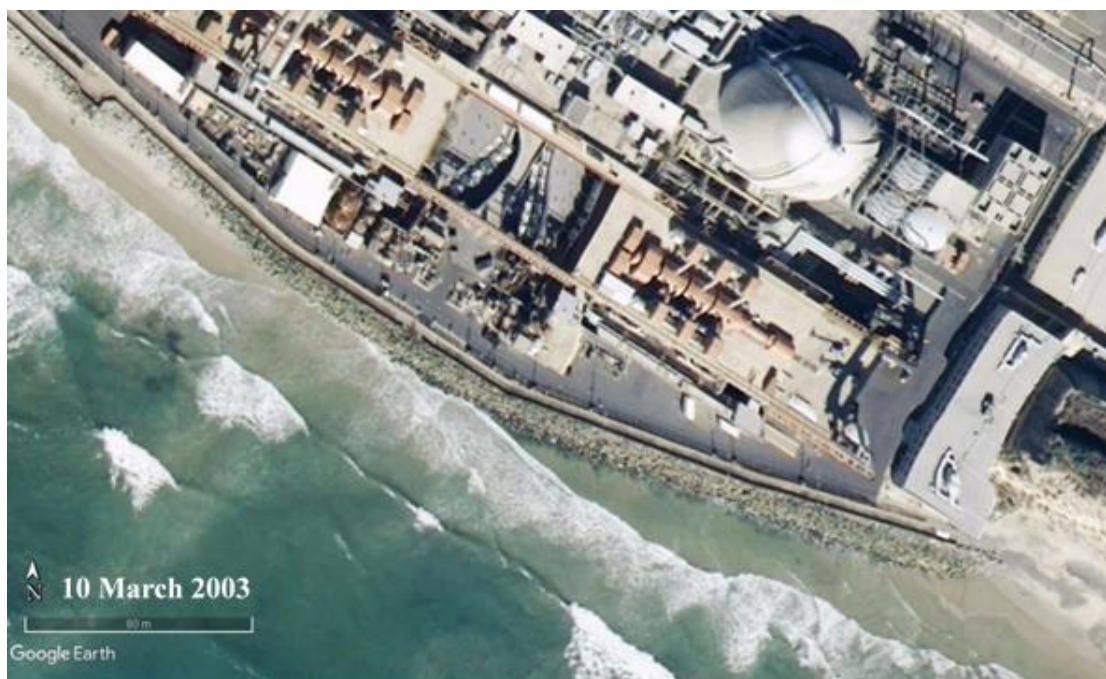
**Photo C-2. Photograph showing waves from north swell attacking SONGS revetment at the southern end of SONGS (10 March 2003).**

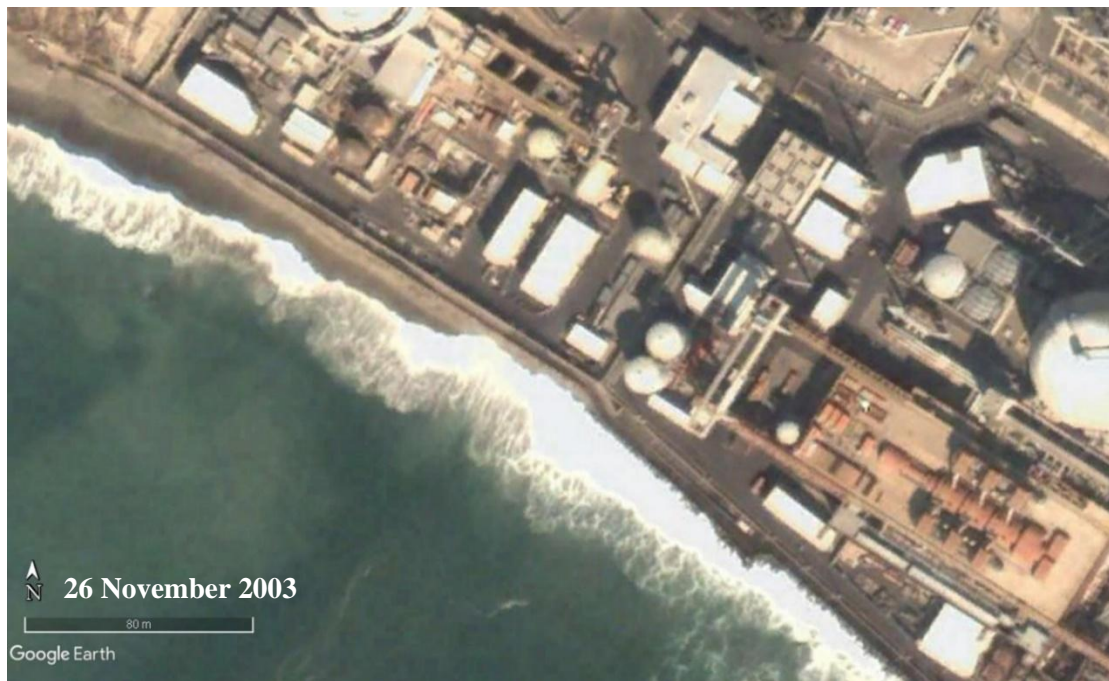
**Photo C-3. Photograph showing waves attacking the revetment and the presence of a sand beach at the northern end of SONGS (26 November 2003).**

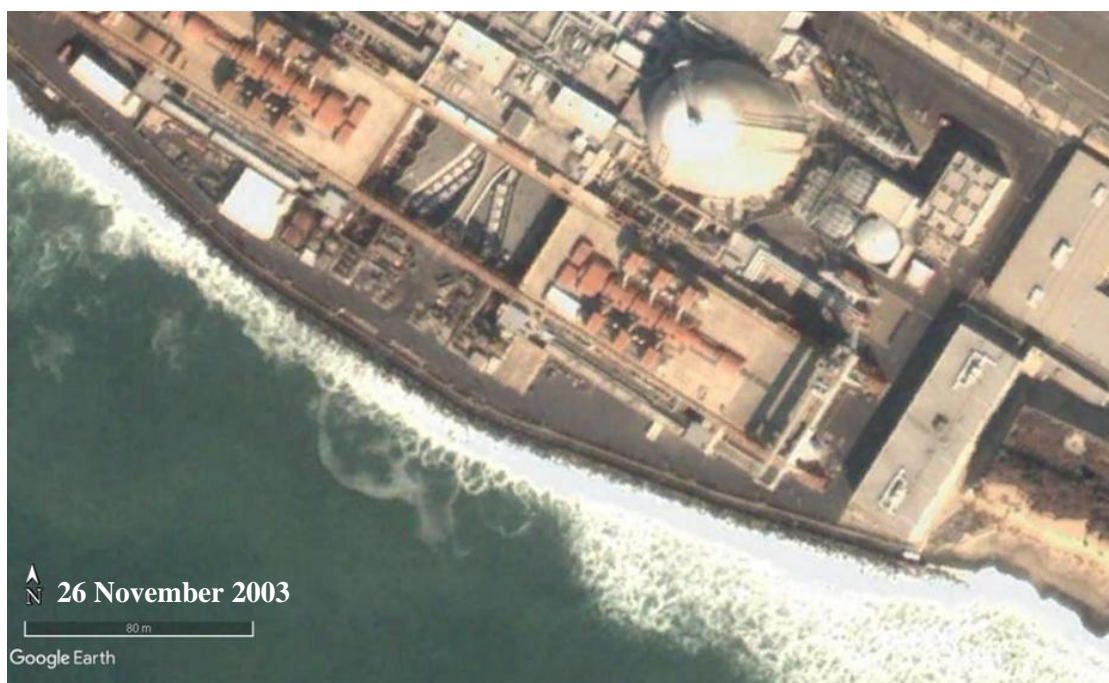
**Photo C-4. Photograph showing waves attacking SONGS revetment at the southern end of SONGS (26 November 2003).**

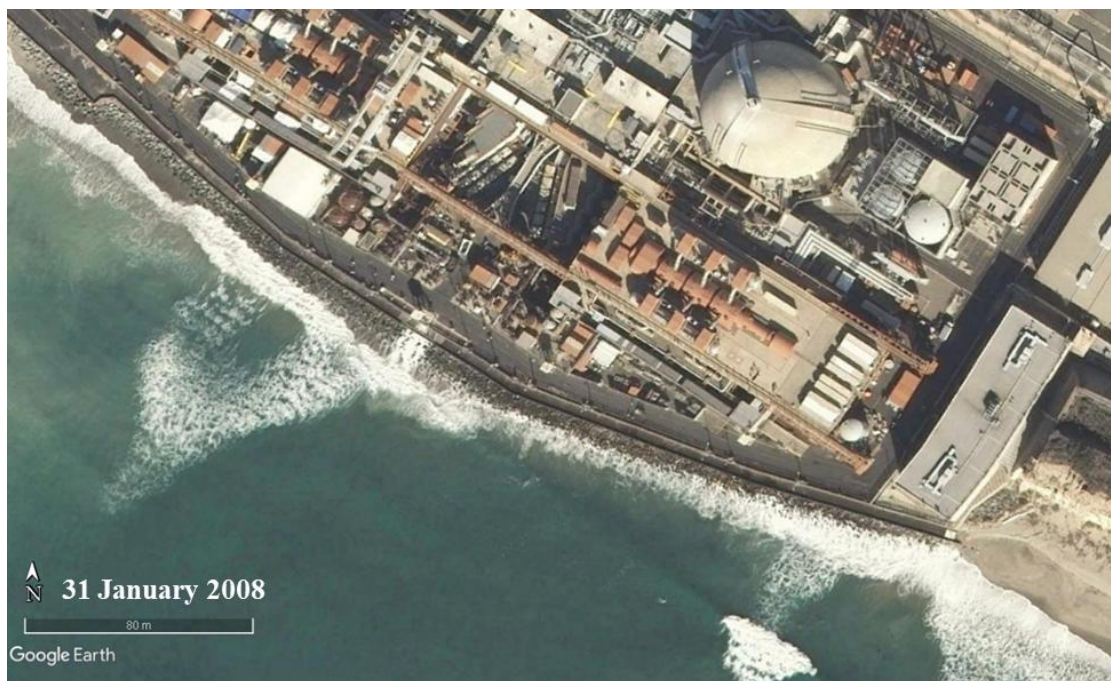
**Photo C-10. Photograph showing waves attacking SONGS revetment at the southern end of SONGS (31 January 2008).**

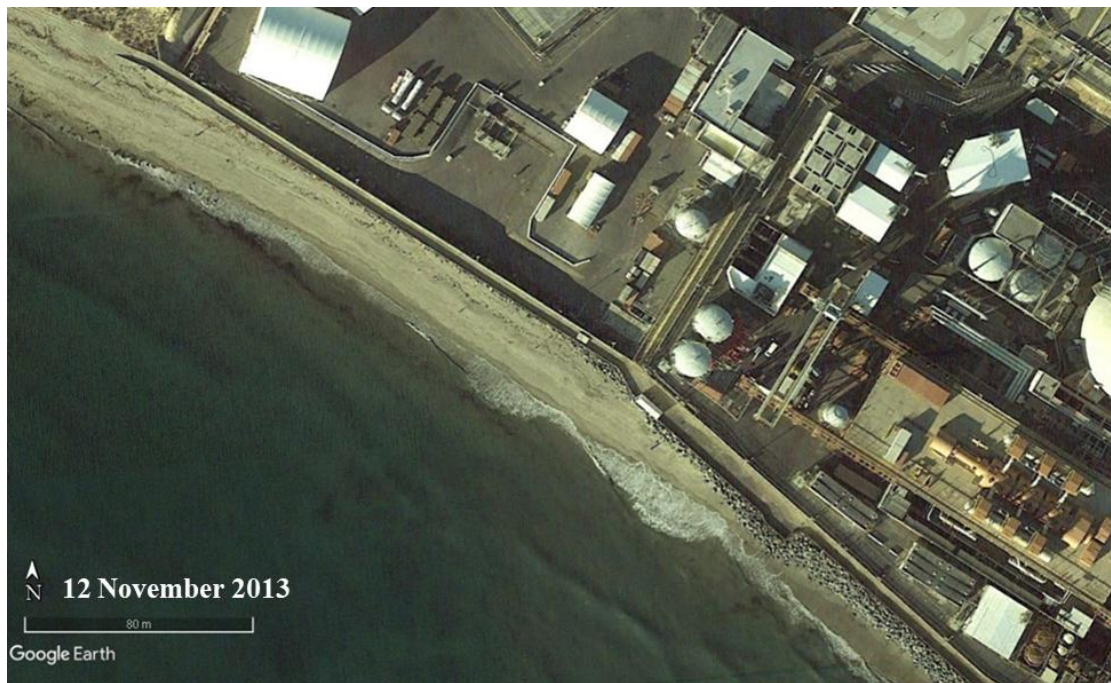
**Photo C-11. Photograph showing revetment covered by sand and fronted by a wide beach at the northern end of SONGS (12 November 2013).**

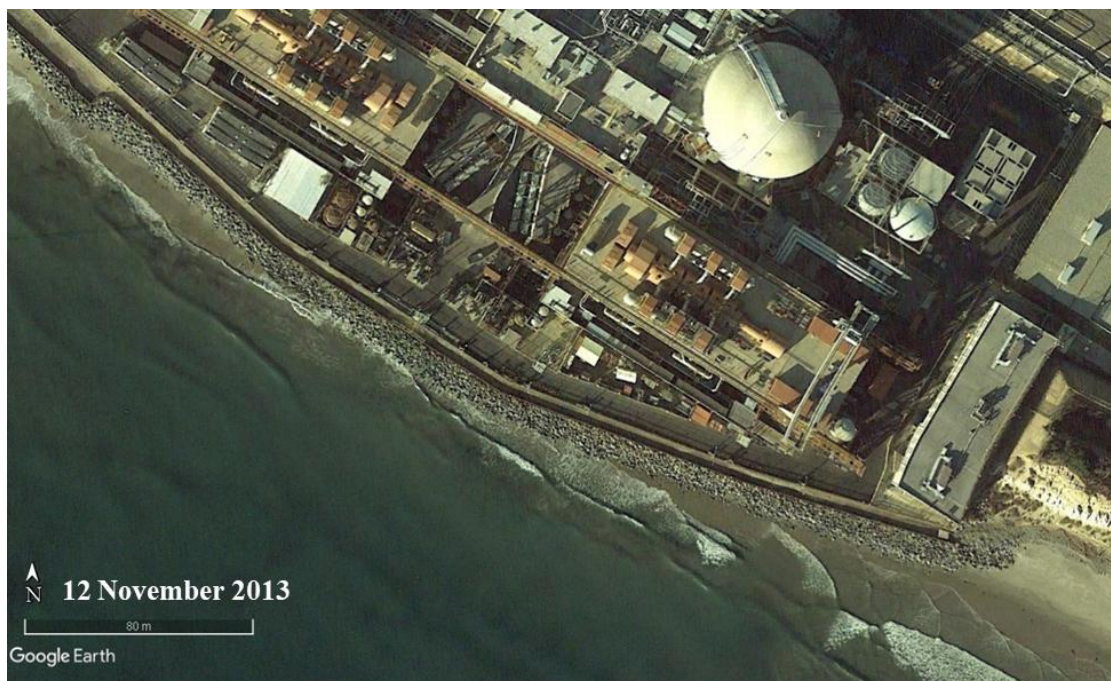
**Photo C-12. Photograph showing waves attacking SONGS revetment and refracting towards south at the southern end of SONGS (12 November 2013).**

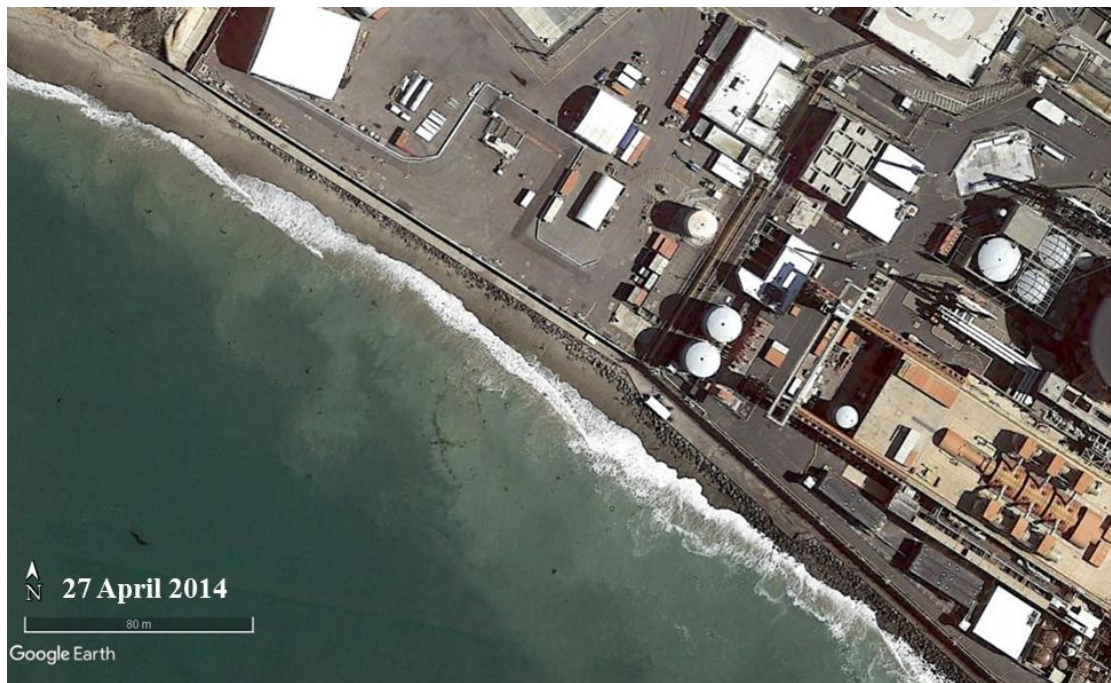
**Photo C-13. Photograph showing revetment exposed and fronted by a wide beach at the northern end of SONGS (27 April 2014).**

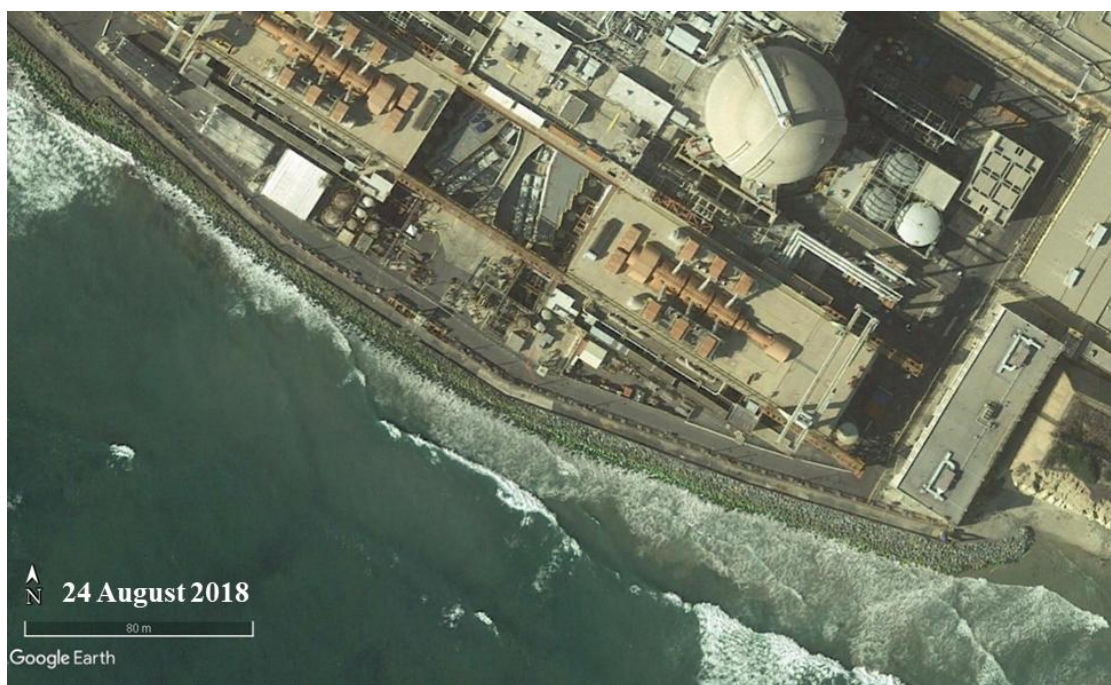
**Photo C-18. Photograph showing waves from north swell attacking SONGS revetment and refracting towards south at the southern end of SONGS (24 August 2018).**

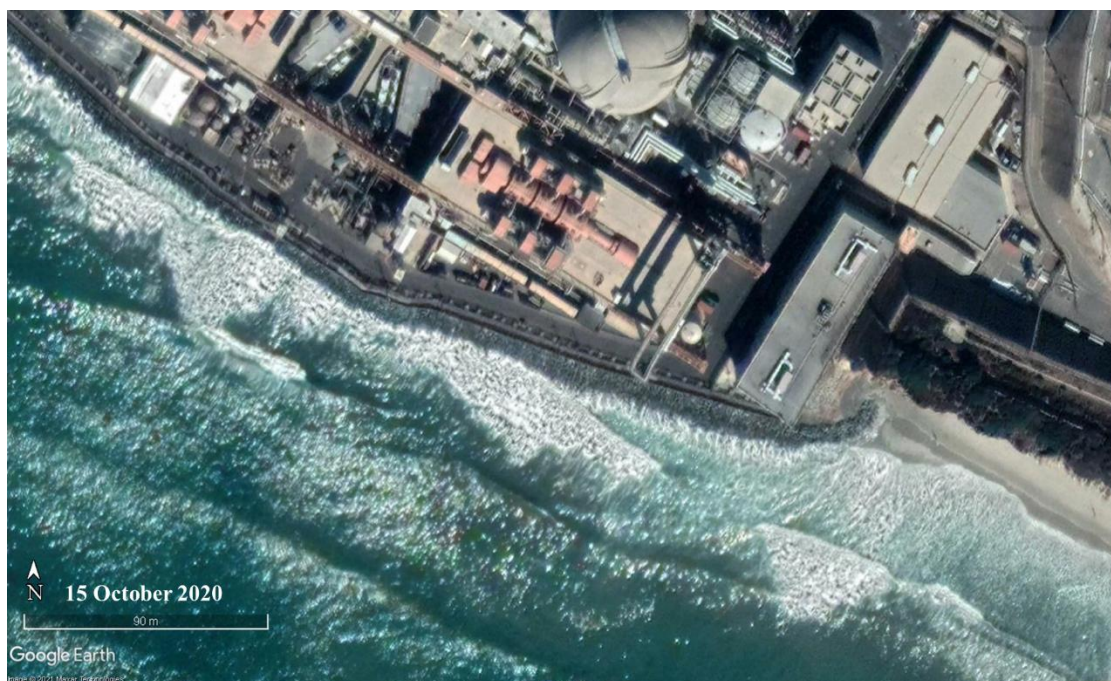
**Photo C-20.** Photograph showing waves attacking SONGS revetment and refracting towards south at the southern end of SONGS (15 October 2020).

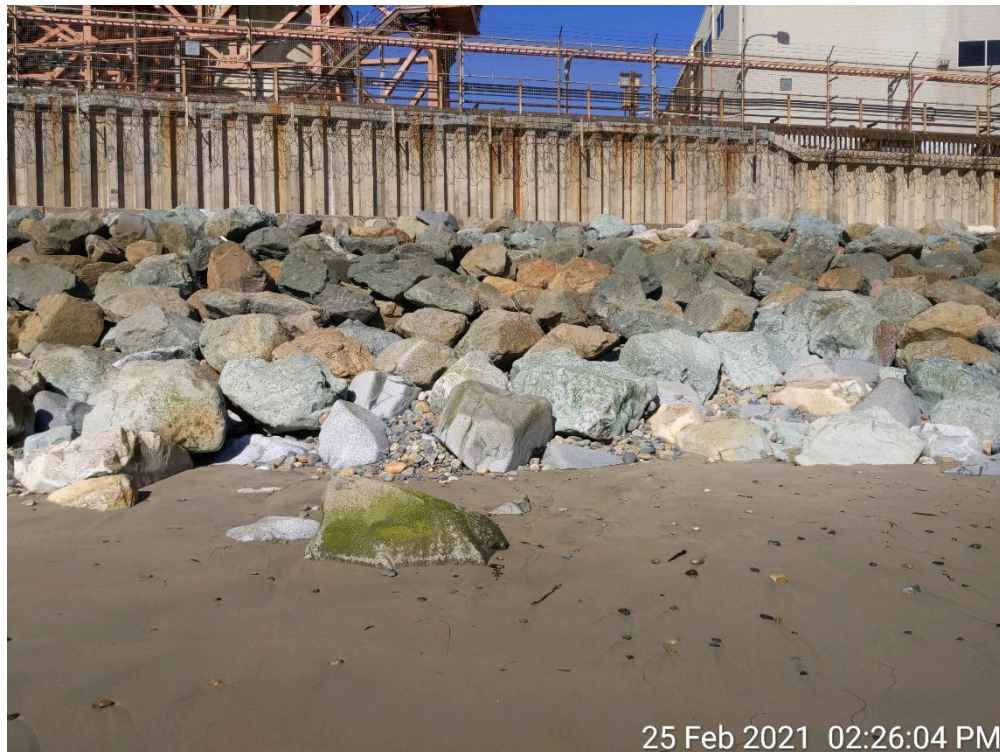
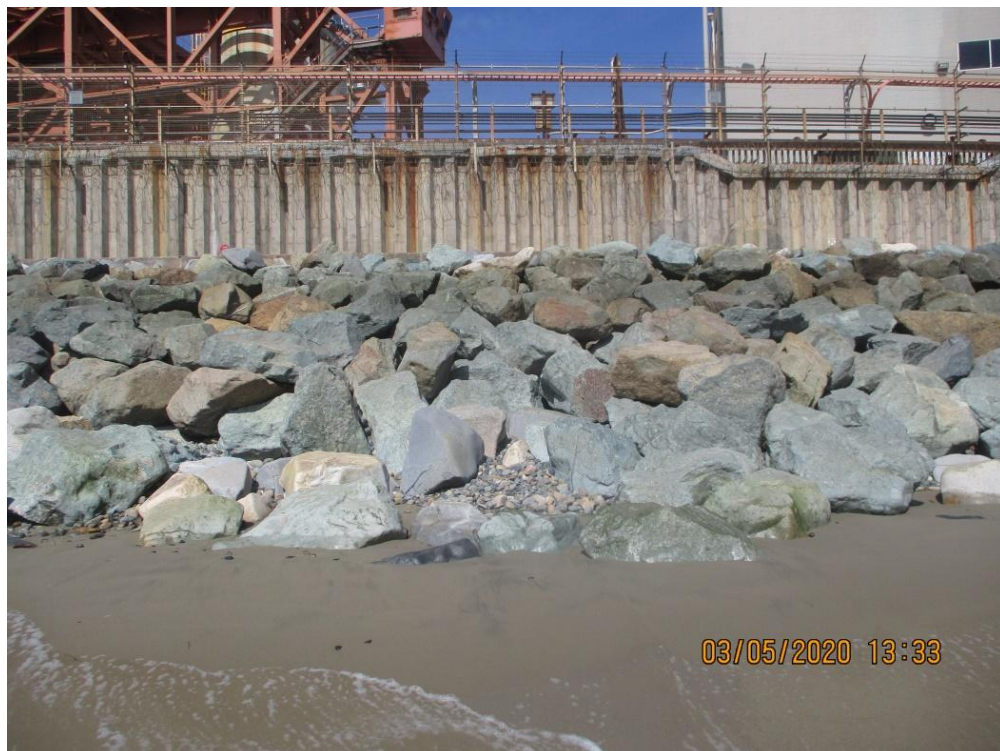
**Photo D-19. Photograph for Transect 19 taken on 25 February 2021 (top) and 5 March 2020 (bottom).**

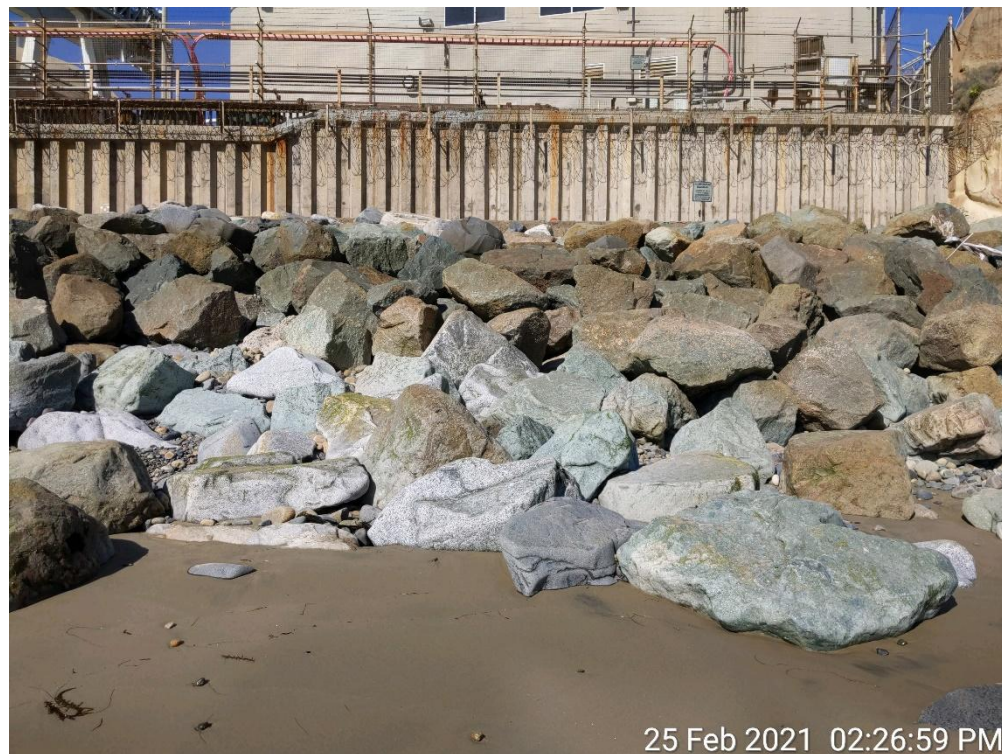
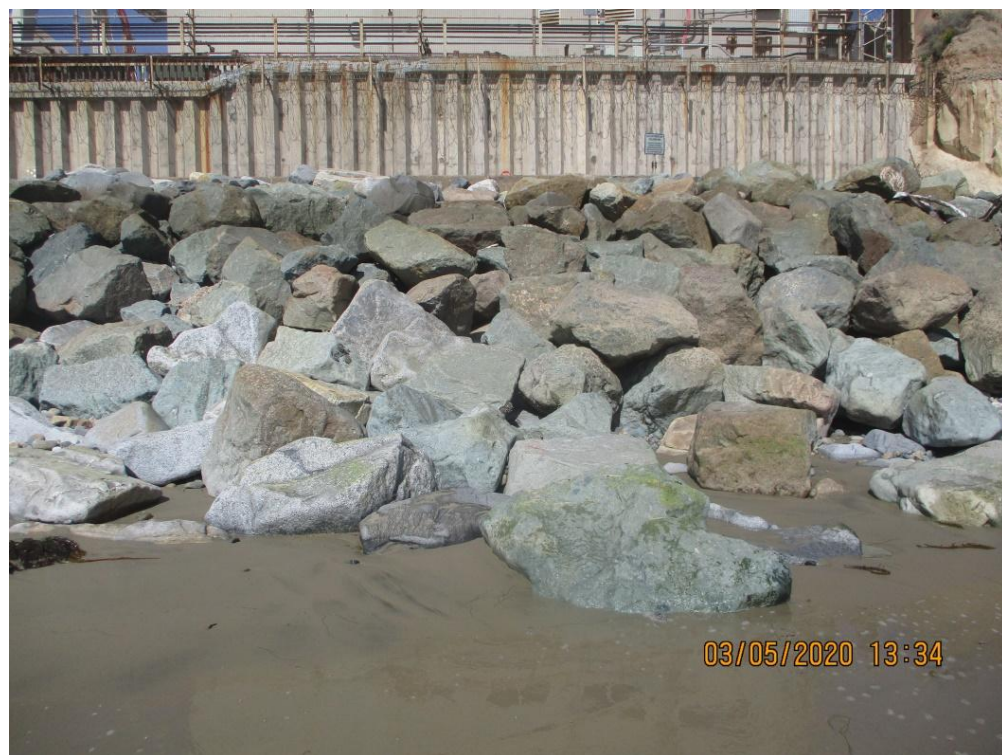
**Photo D-20. Photograph for Transect 20 taken on 25 February 2021 (top) and 5 March 2020 (bottom).**

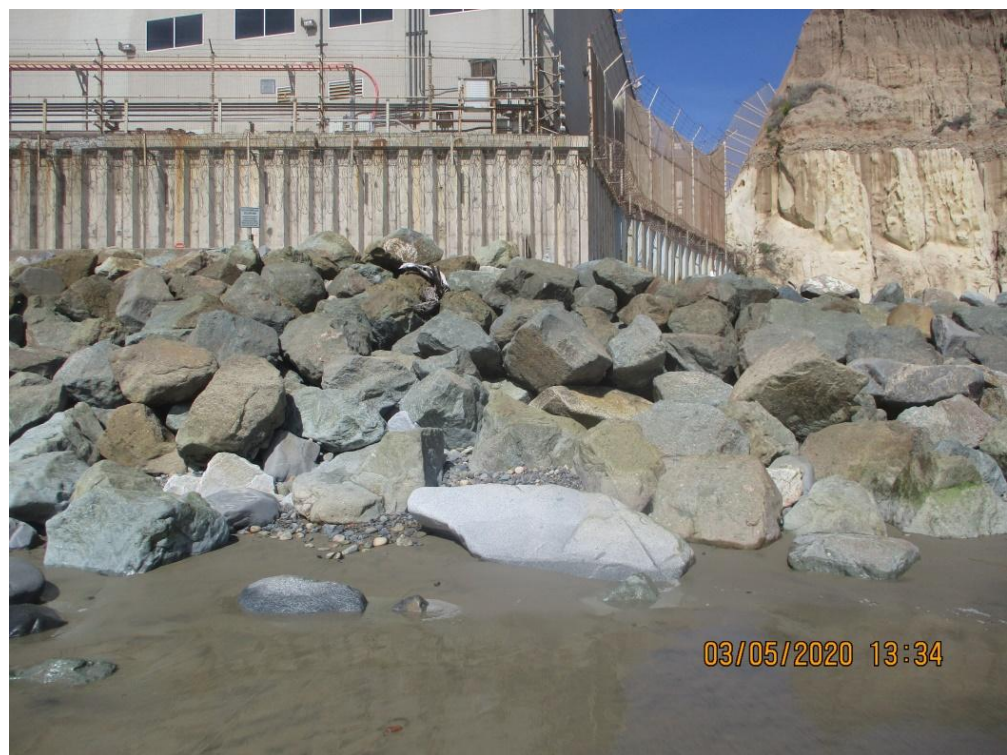
**Photo D-21. Photograph for Transect 21 taken on 25 February 2021 (top) and 5 March 2020 (bottom).**
