**SAN ONOFRE NUCLEAR GENERATING STATION (SONGS)  
SONGS MEAN SEA LEVEL RISE IMPACT ASSESSMENT**

**Technical Report for  
CSLC Special Provision 14 in Lease No. PRC 6785.1**

CE Reference No. 21-07  
25 March 2021

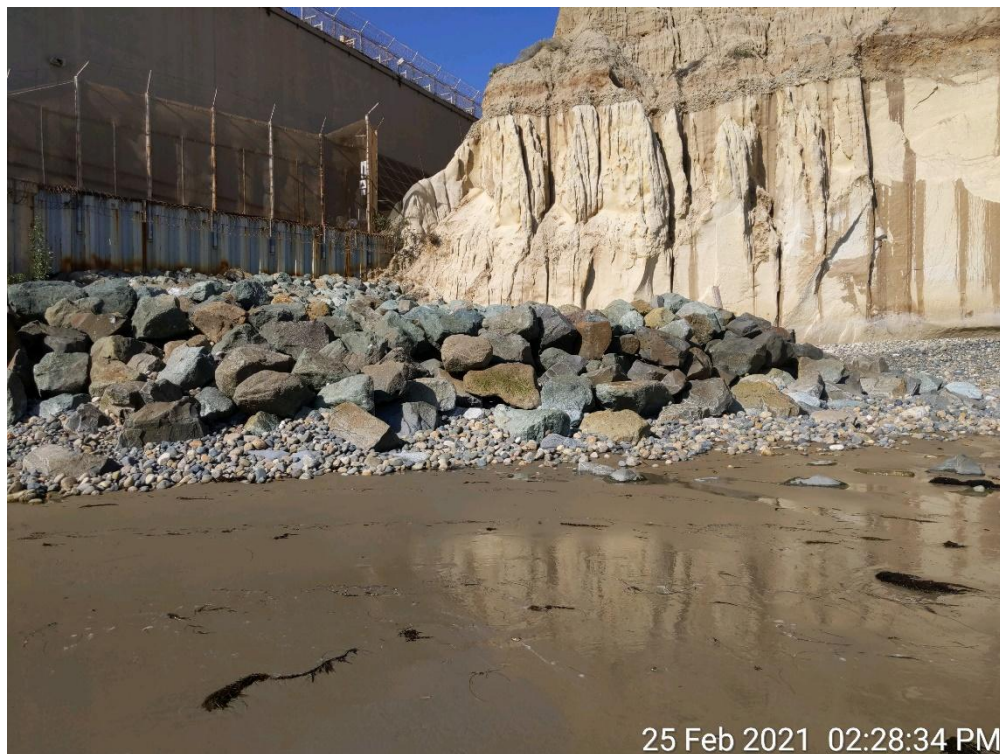
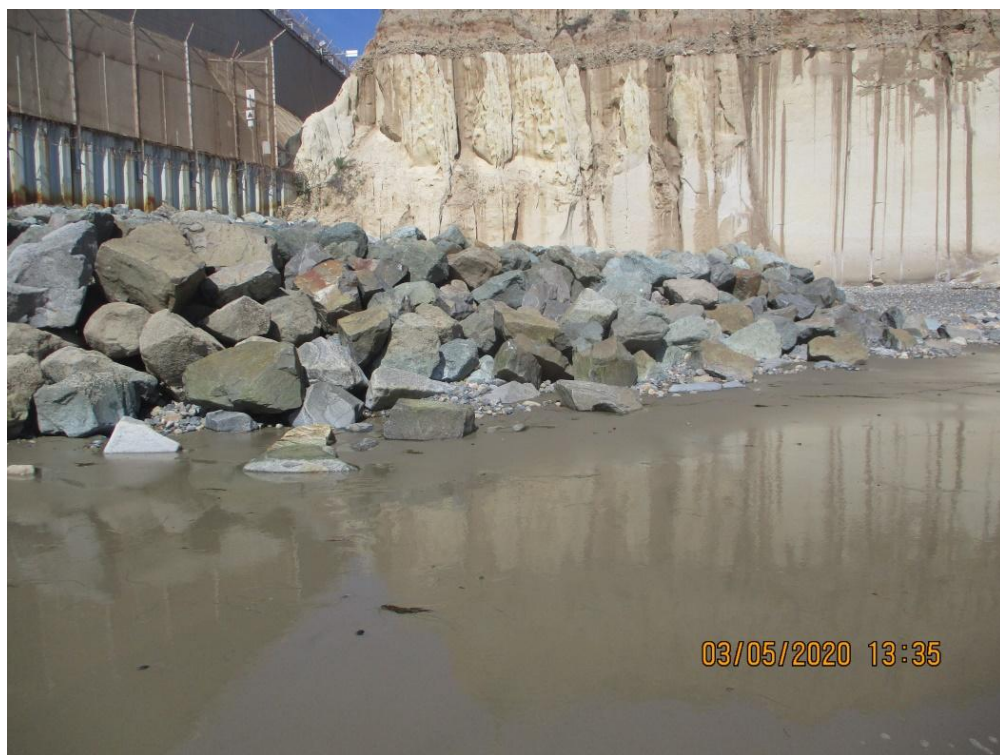
**Photo D-24. Photograph showing the end of southern riprap at end of walkway taken on 25 February 2021 (top) and 5 March 2020 (bottom).**

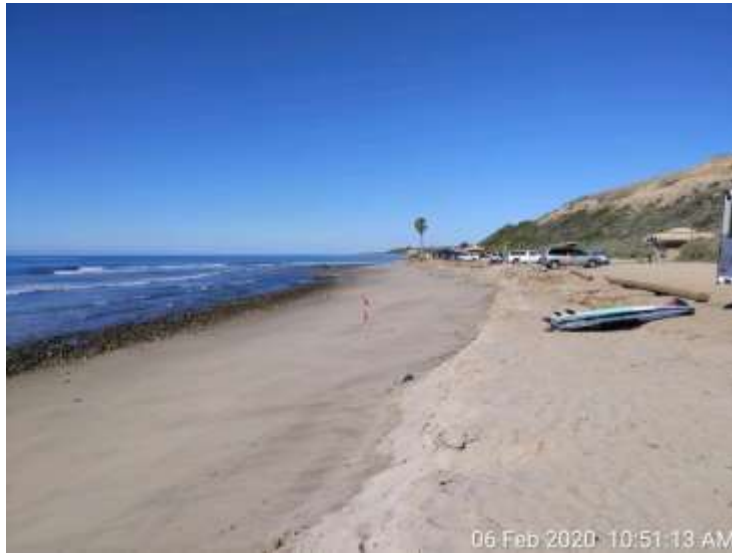
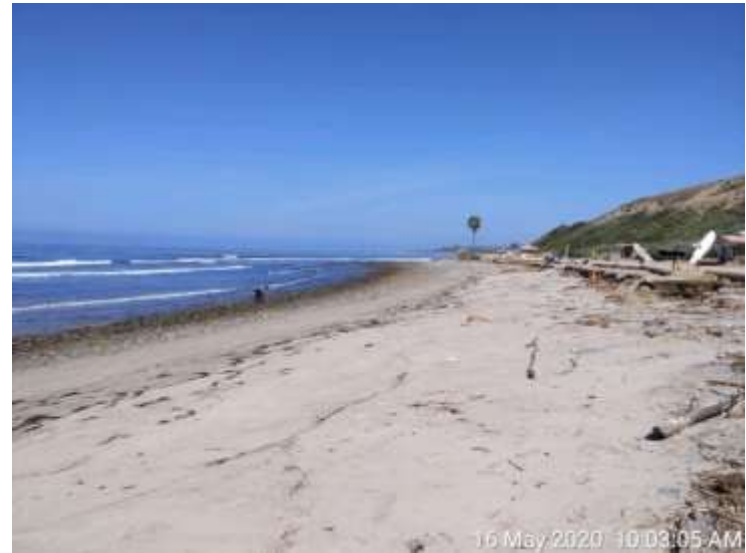
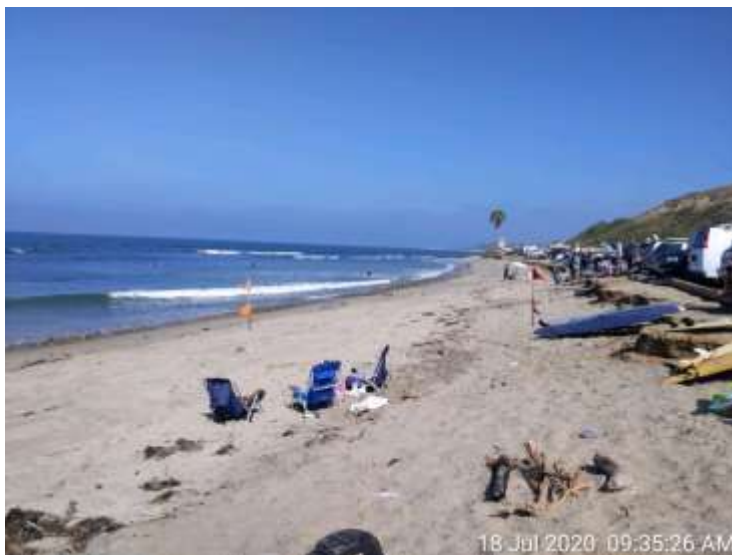
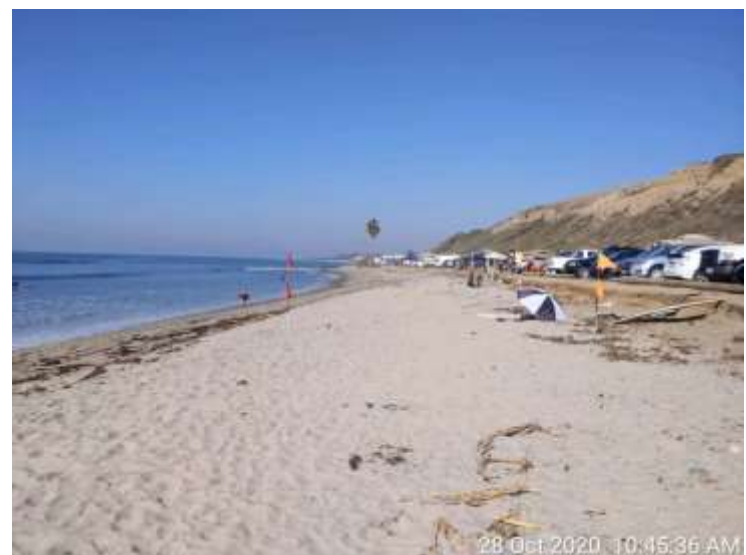
**Photo B-1. Photographs taken in February (top left), May (top right), July (bottom left), and October 2020 (bottom right) looking north from range N1000.**

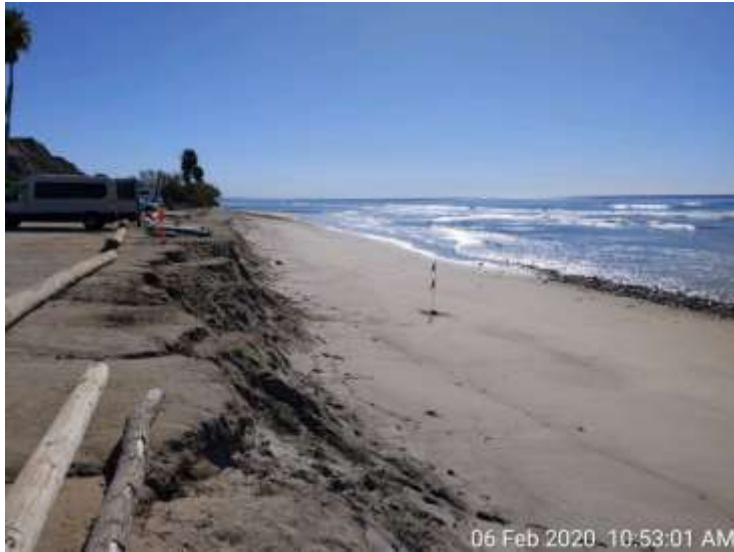
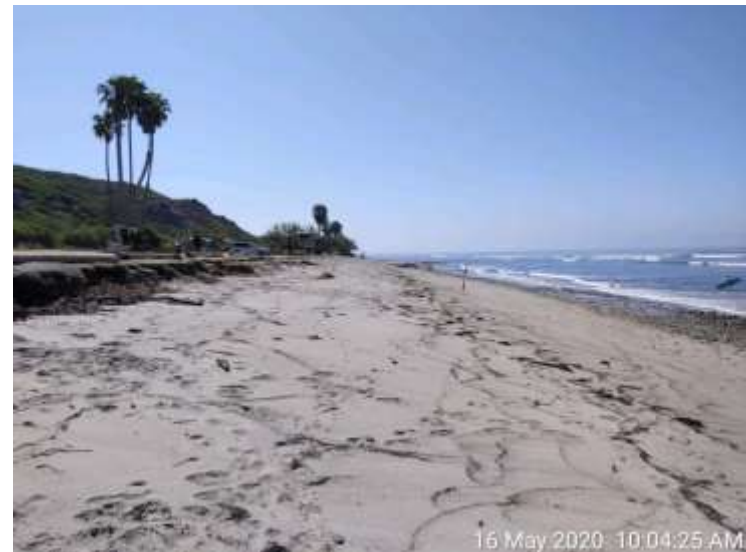
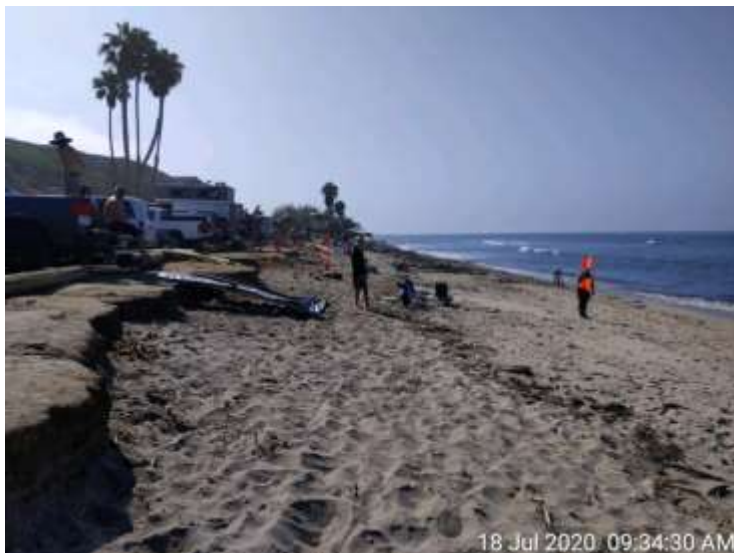
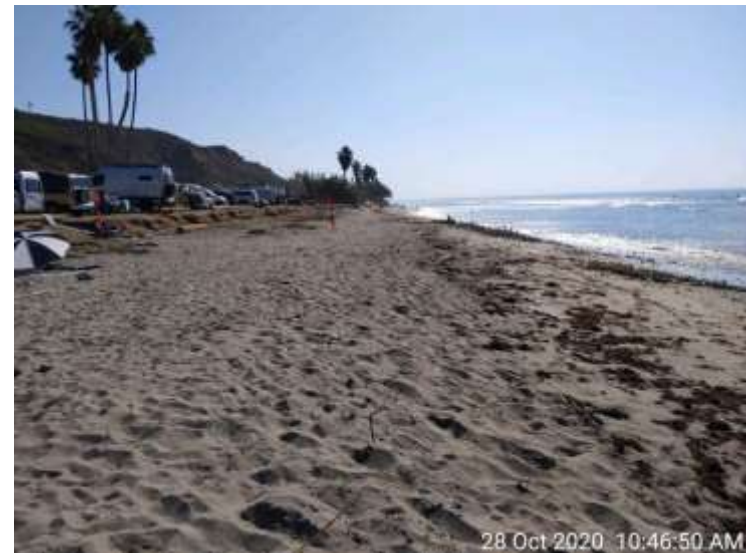
**Photo B-2. Photographs taken in February (top left), May (top right), July (bottom left), and October 2020 (bottom right) looking south from range N1000.**

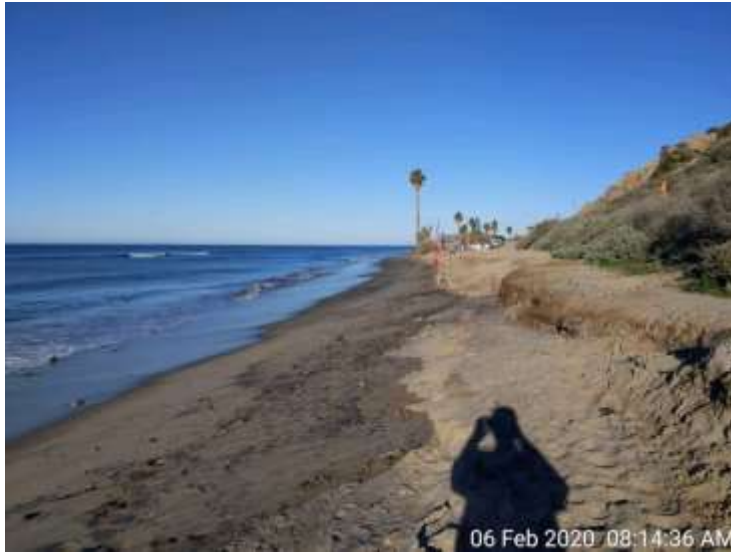
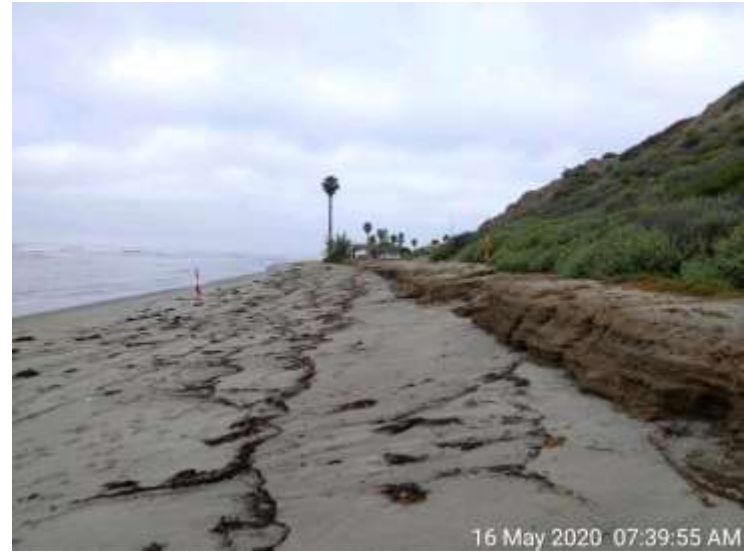
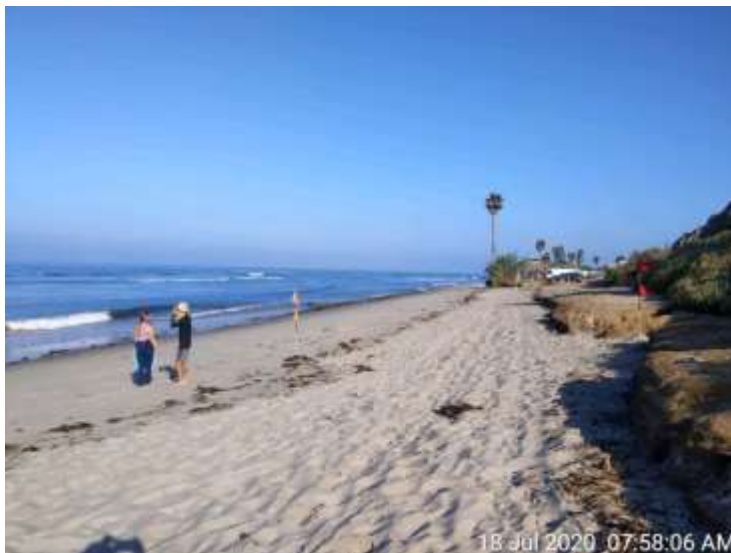
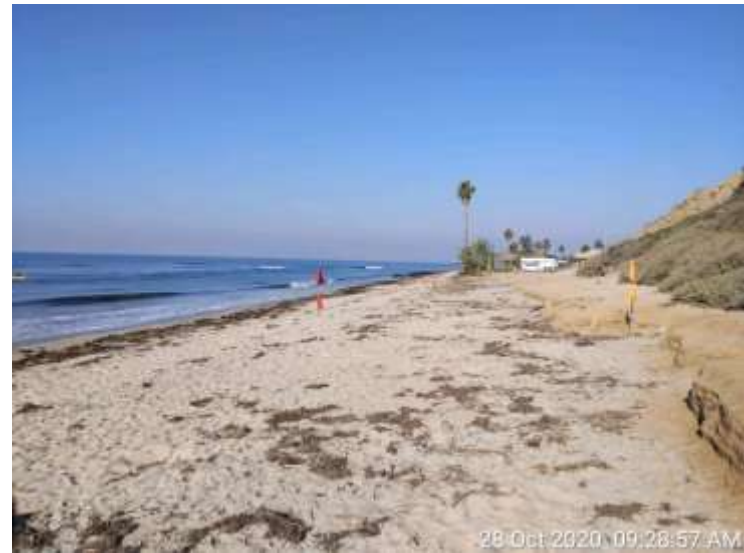
**Photo B-3. Photographs taken in February (top left), May (top right), July (bottom left), and October 2020 (bottom right) looking north from range N0500.**

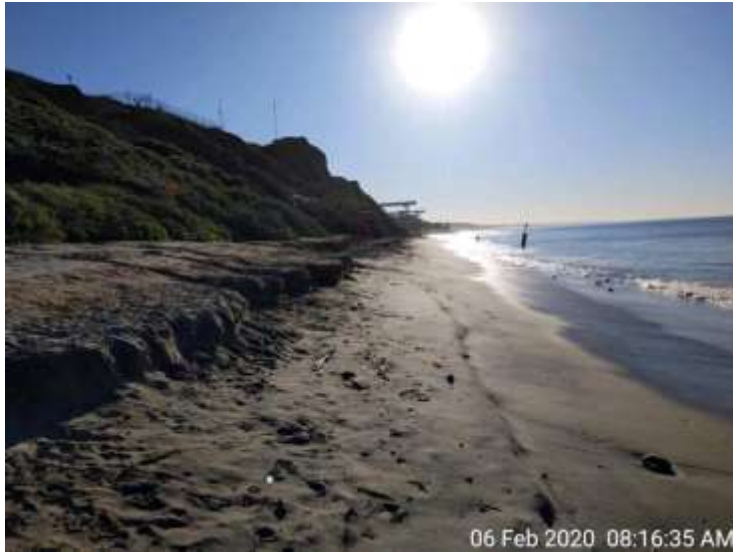
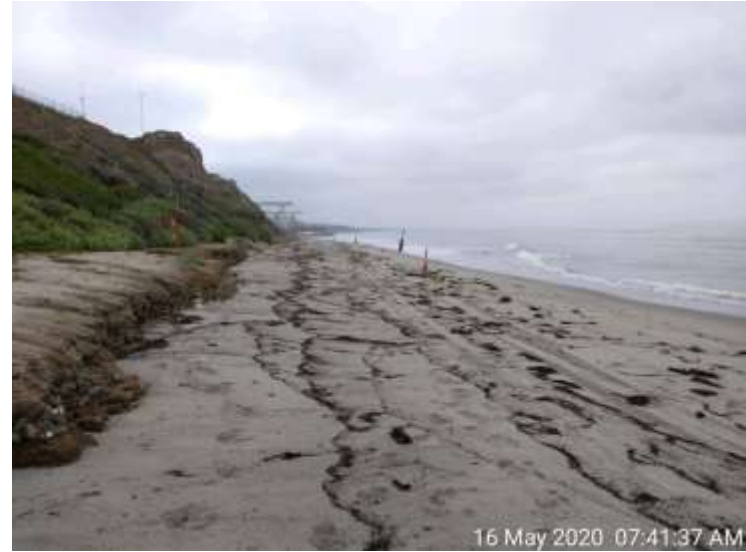
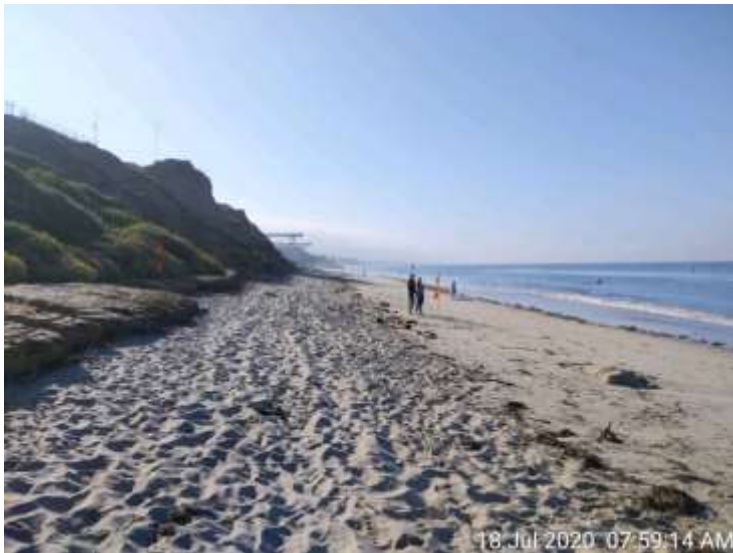
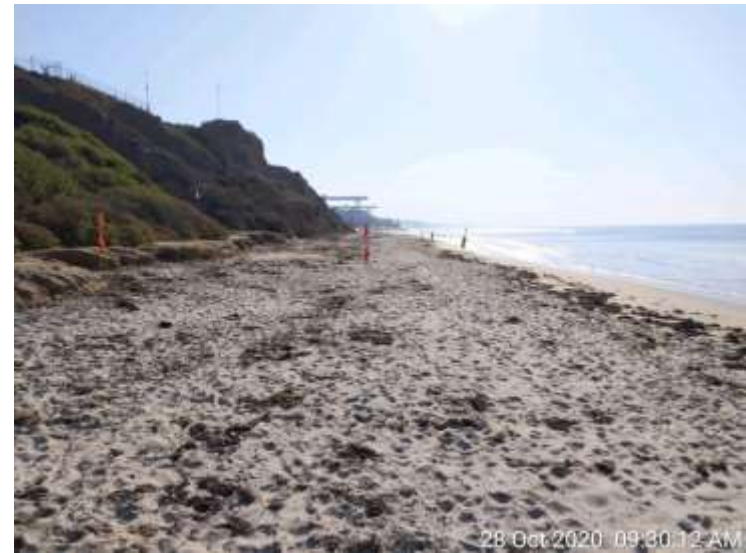
**Photo B-4. Photographs taken in February (top left), May (top right), July (bottom left), and October 2020 (bottom right) looking south from range N0500.**

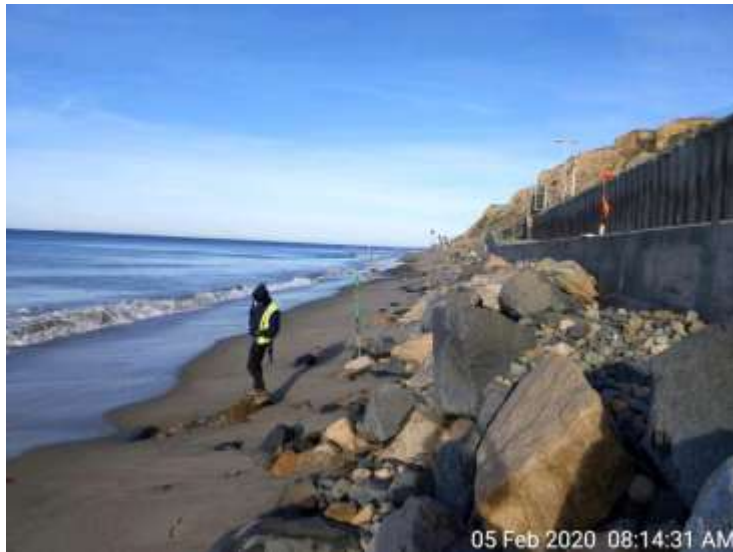
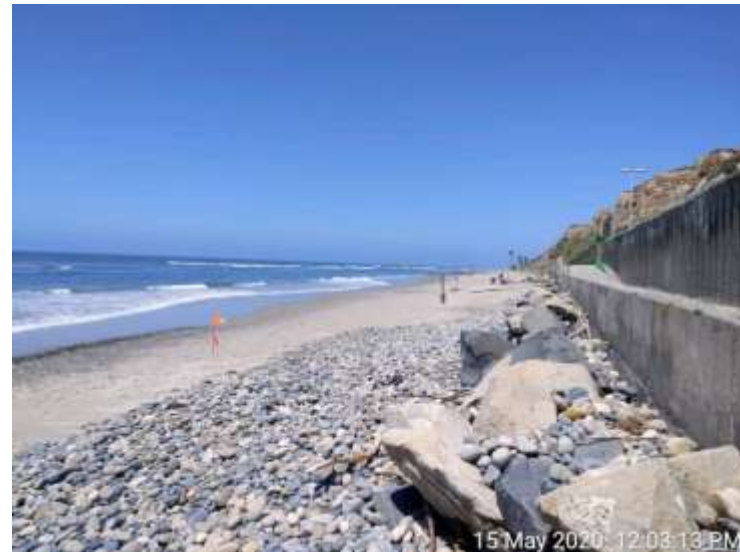
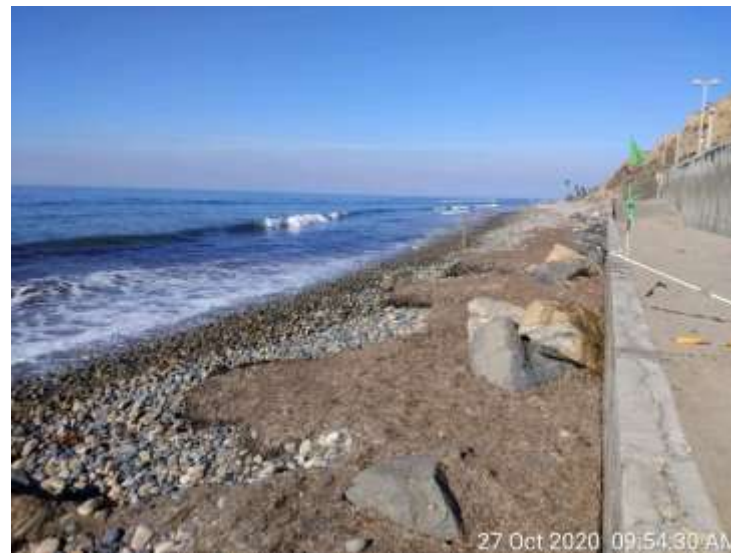
**Photo B-5. Photographs taken in February (top left), May (top right), and October 2020 (bottom) looking north from range N0400'.**

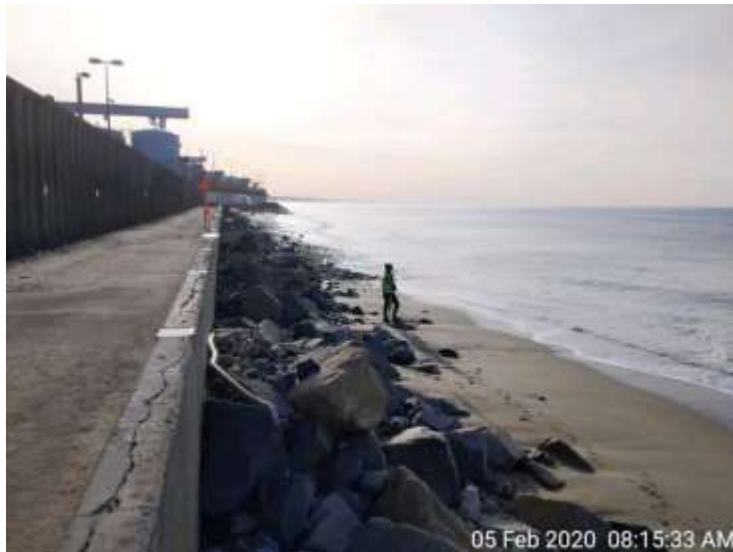
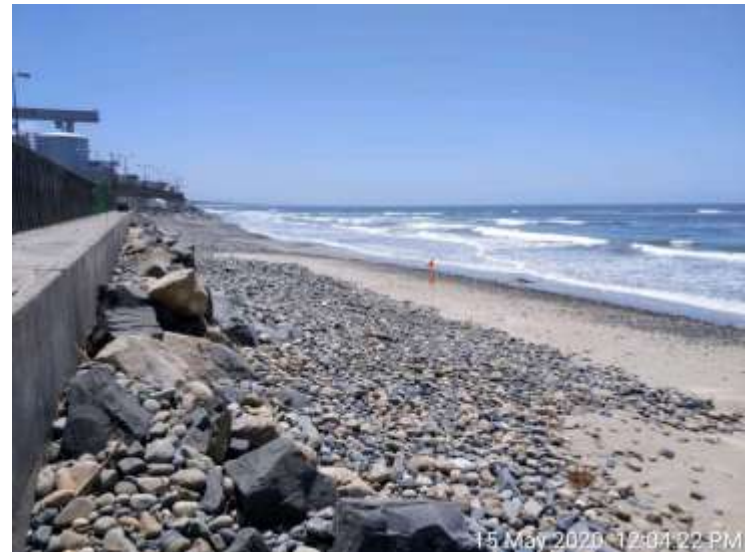
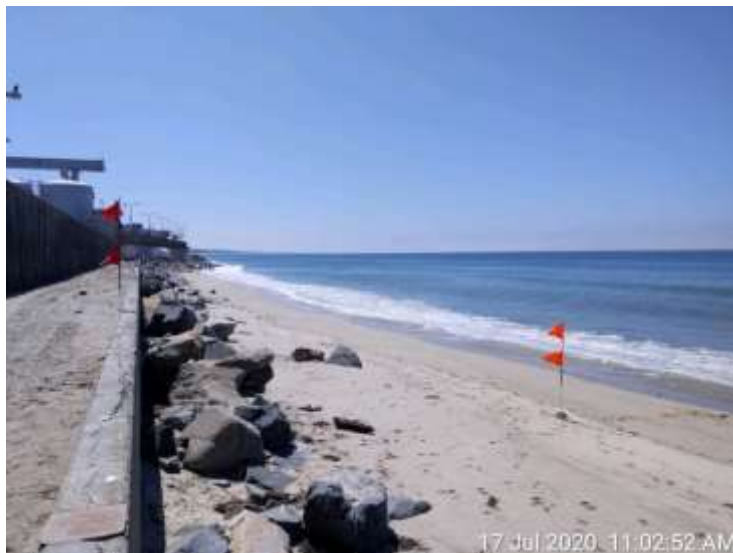
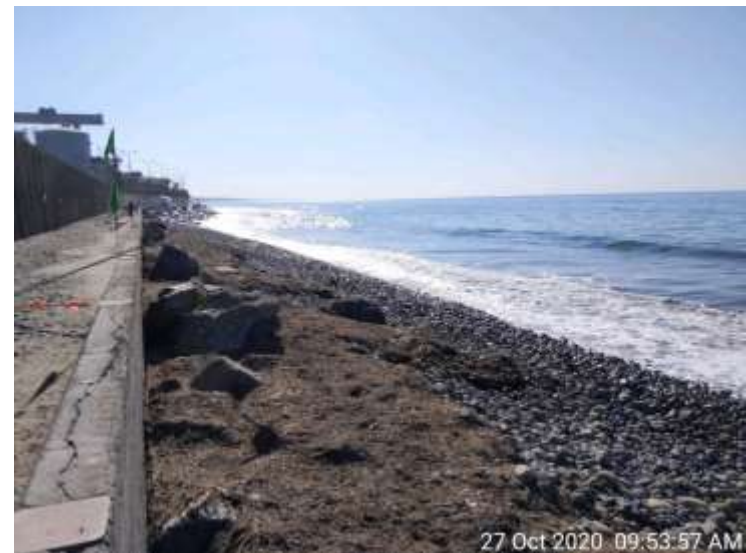
**Photo B-6. Photographs taken in February (top left), May (top right), July (bottom left), and October 2020 (bottom right) looking south from range N0400'.**

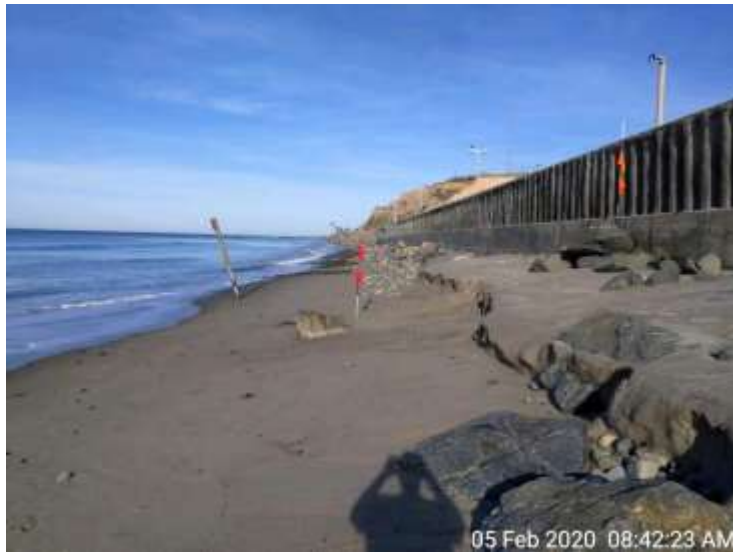
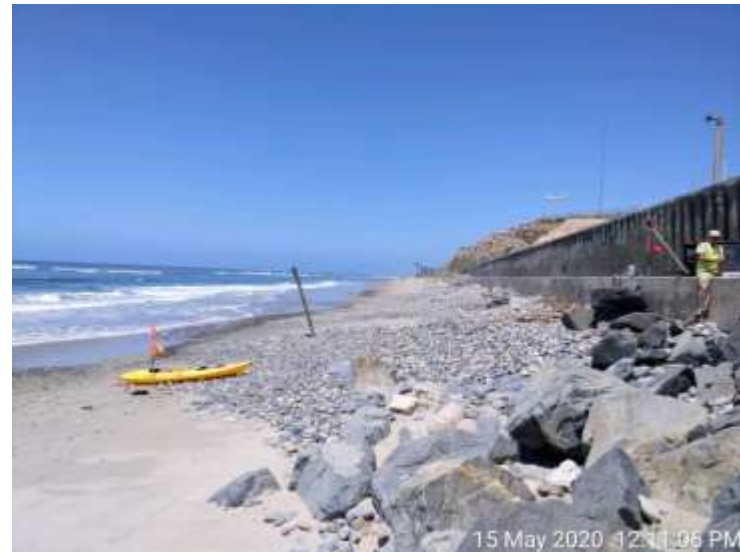
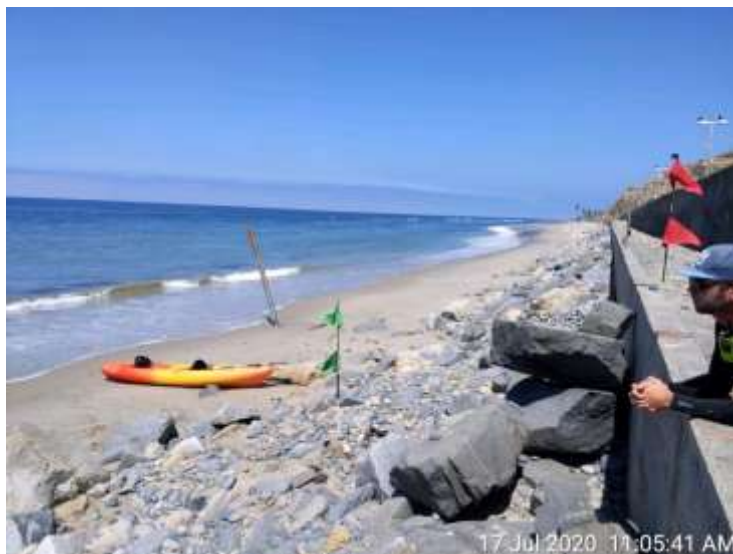
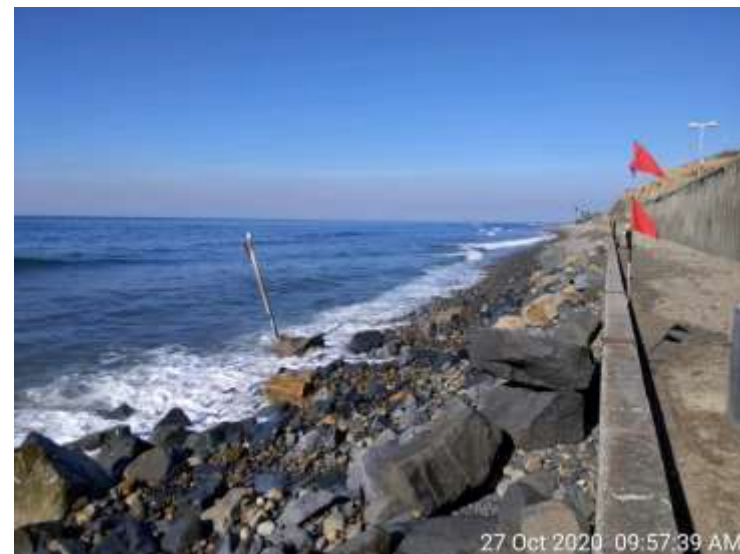
**Photo B-7. Photographs taken in February (top left), May (top right), July (bottom left), and October 2020 (bottom right) looking north from range NS0000.**

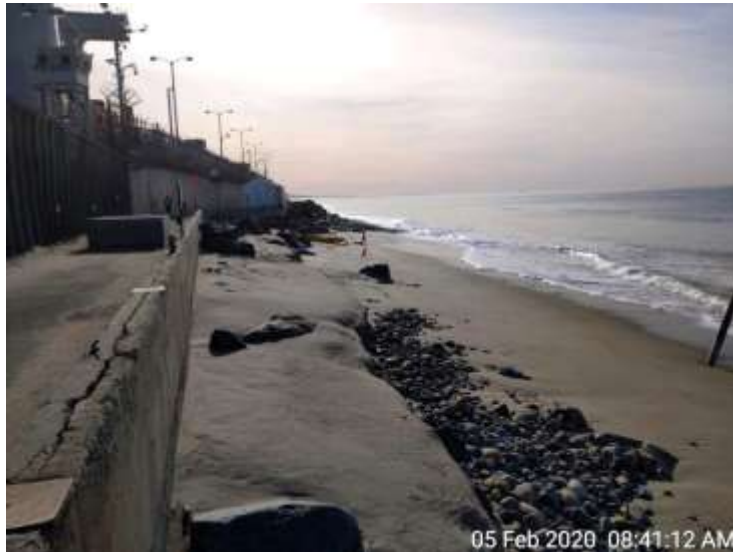
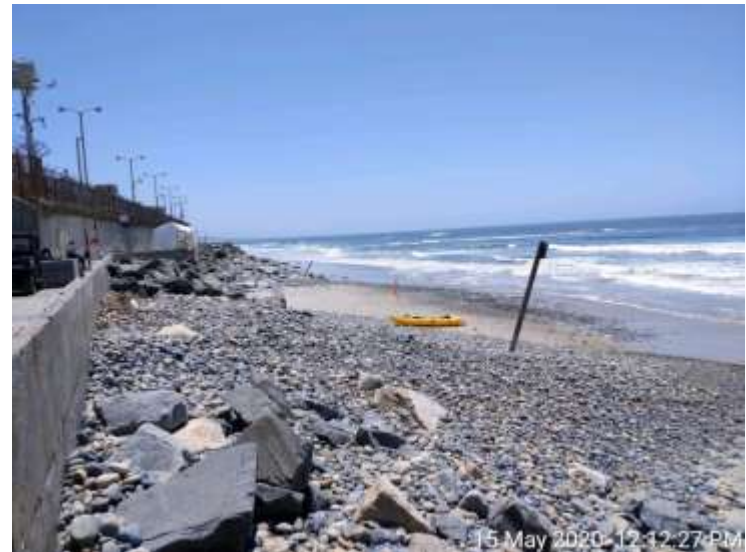
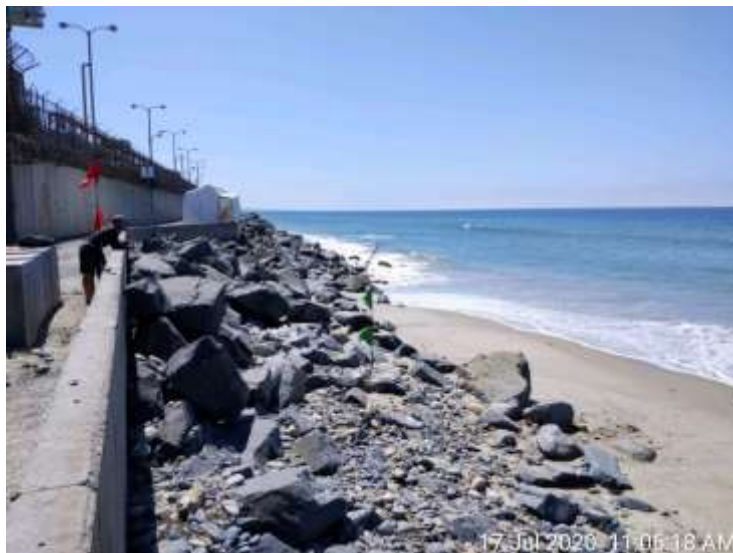
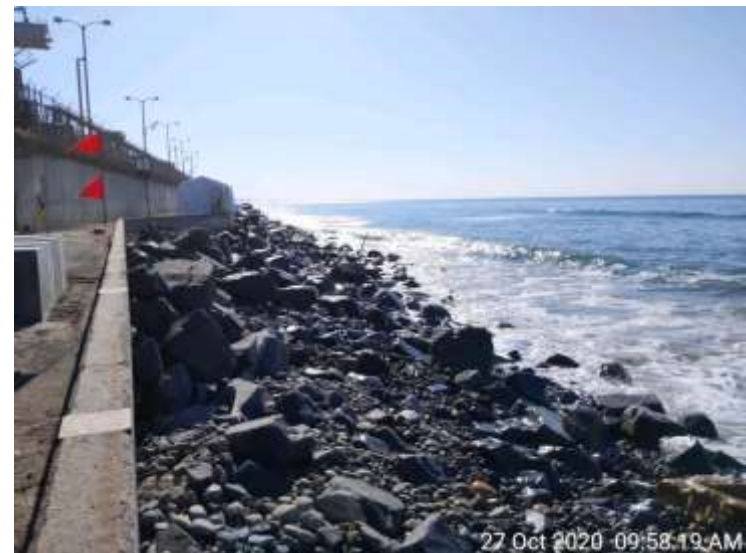
**Photo B-8. Photographs taken in February (top left), May (top right), July (bottom left), and October 2020 (bottom right) looking south from range NS0000.**

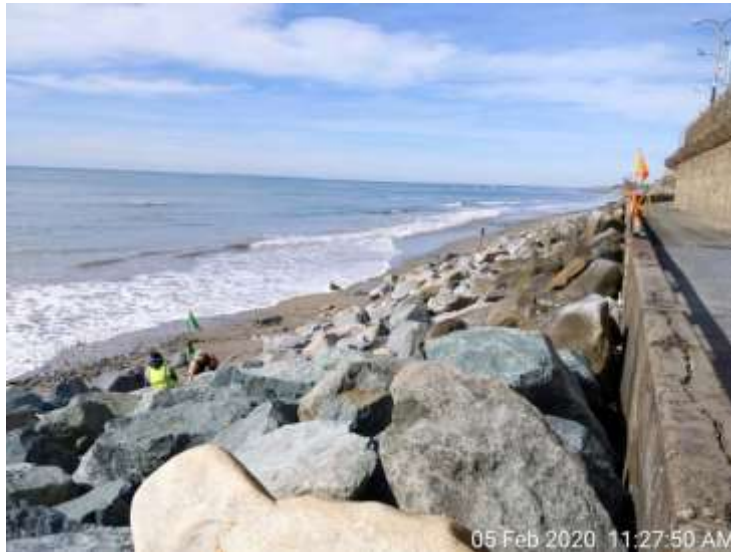
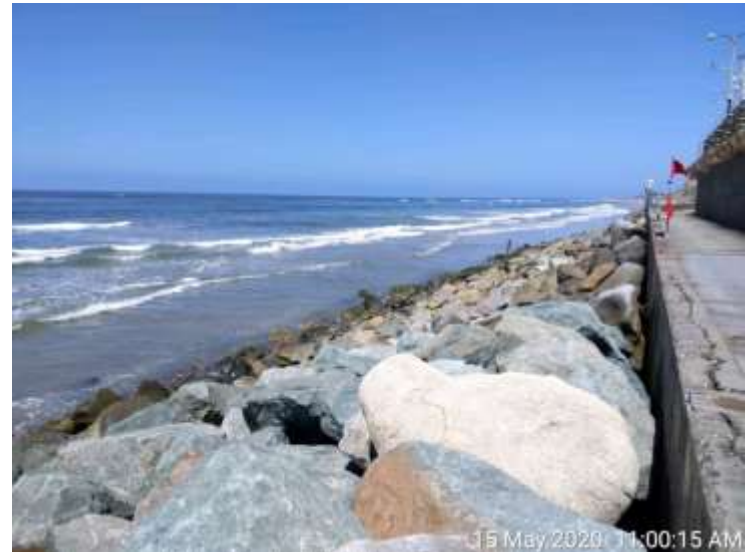
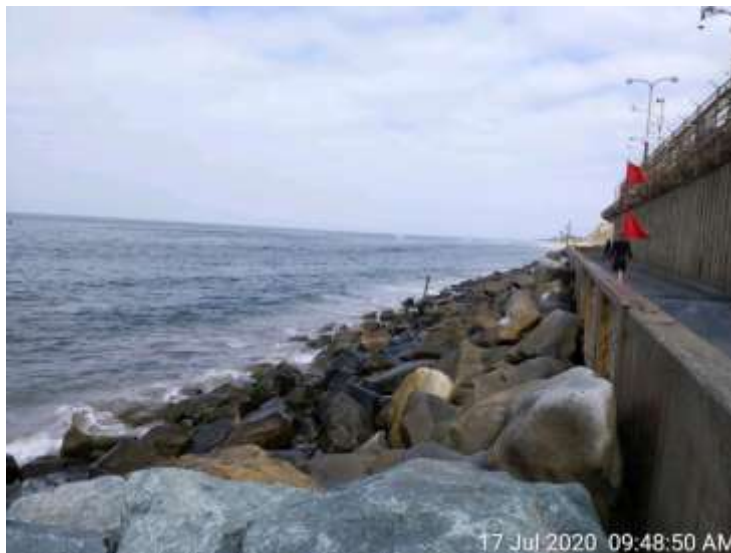
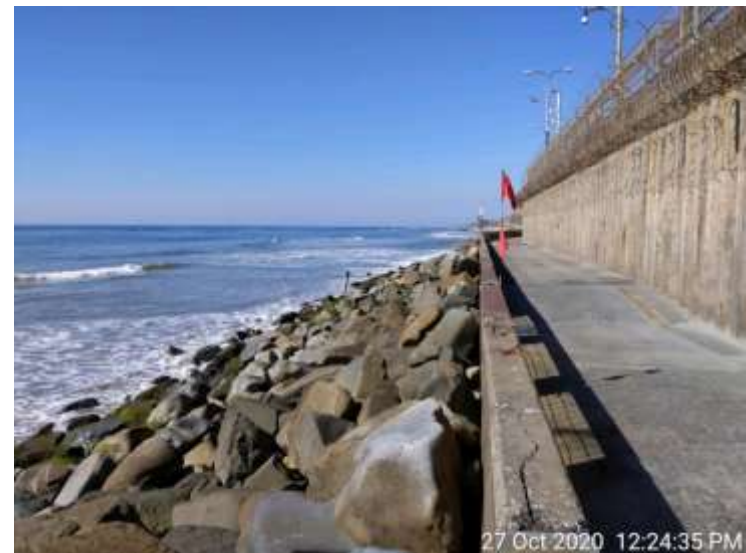
**Photo B-9. Photographs taken in February (top left), May (top right), July (bottom left), and October 2020 (bottom right) looking north from range S0800'.**

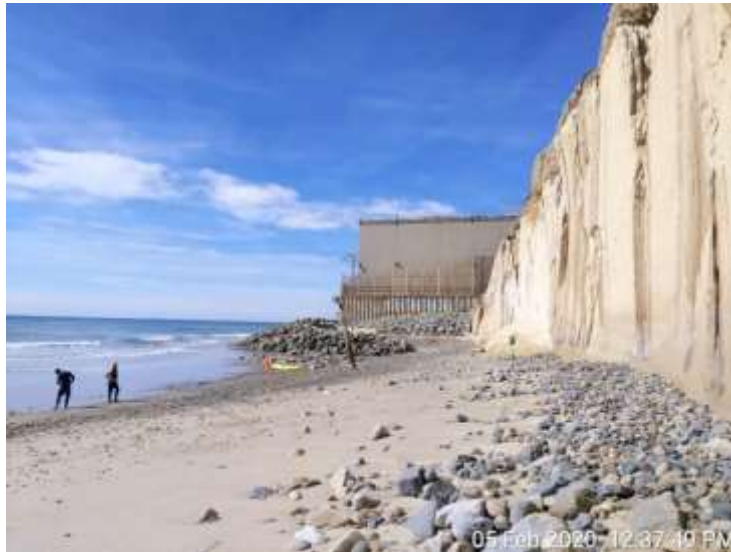
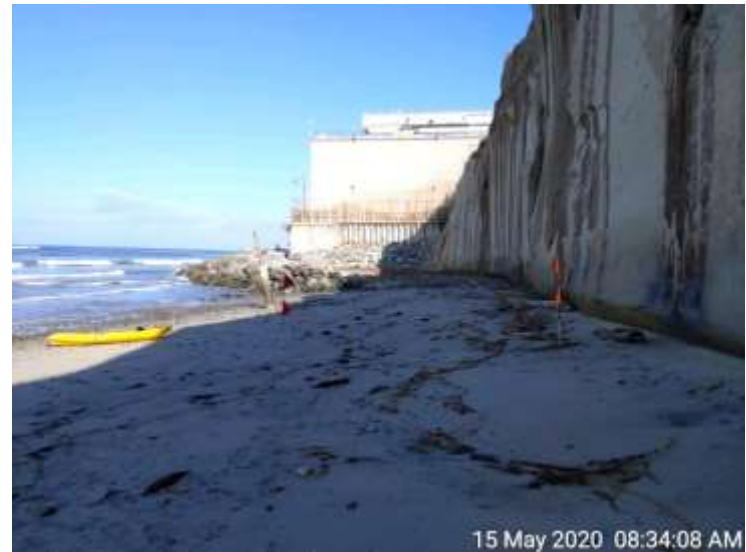
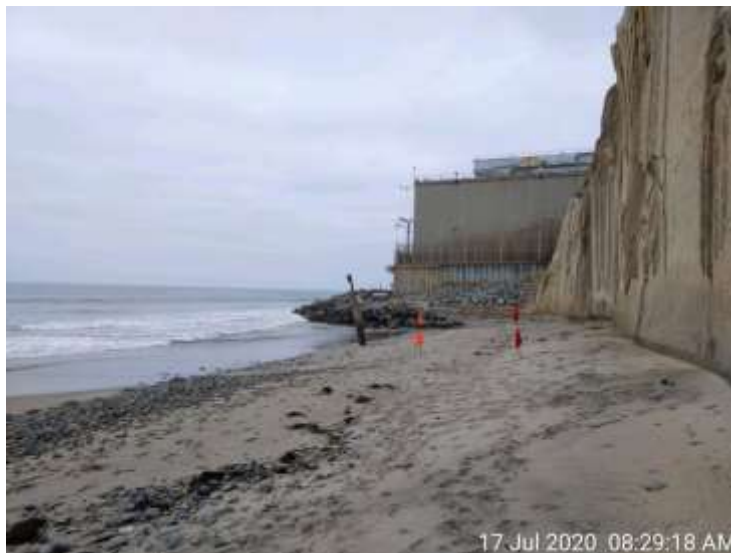
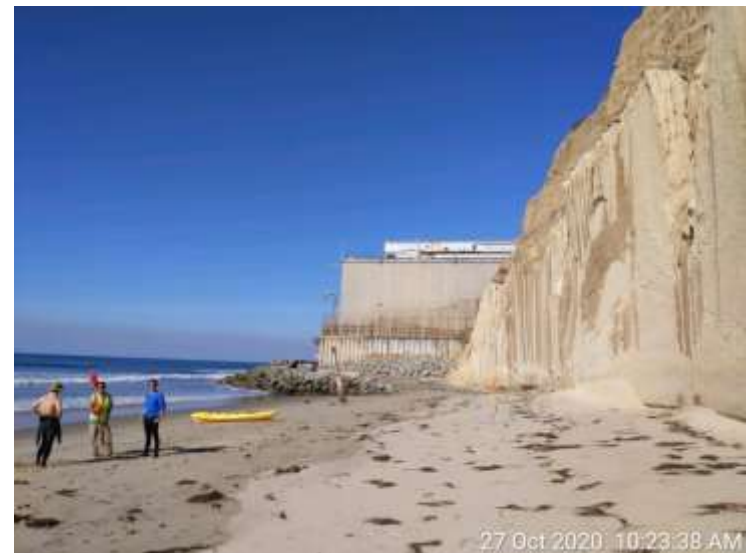
**Photo B-11. Photographs taken in February (top left), May (top right), July (bottom left), and October 2020 (bottom right) looking north from range S0500.**

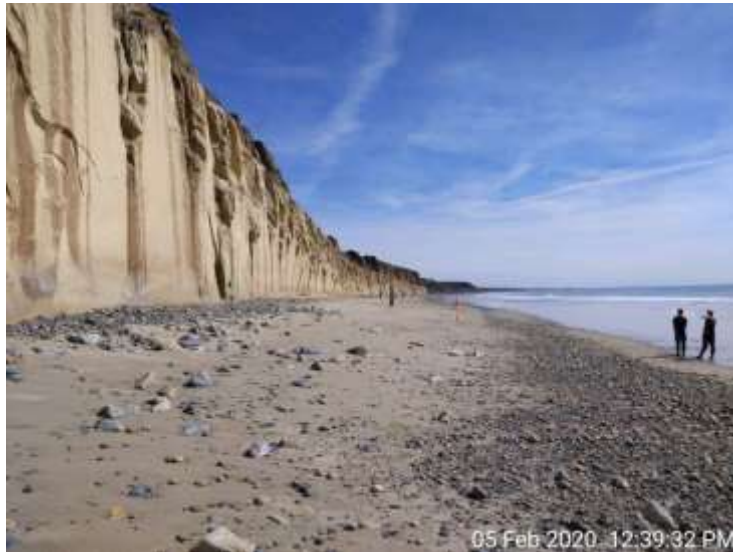
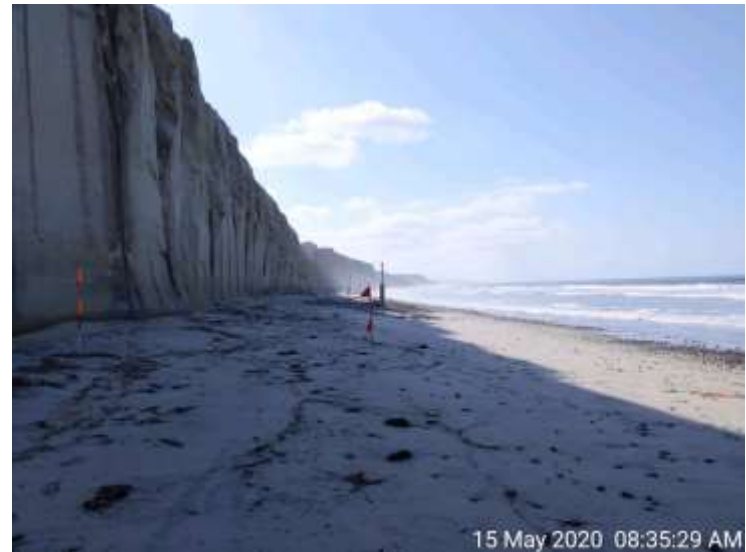
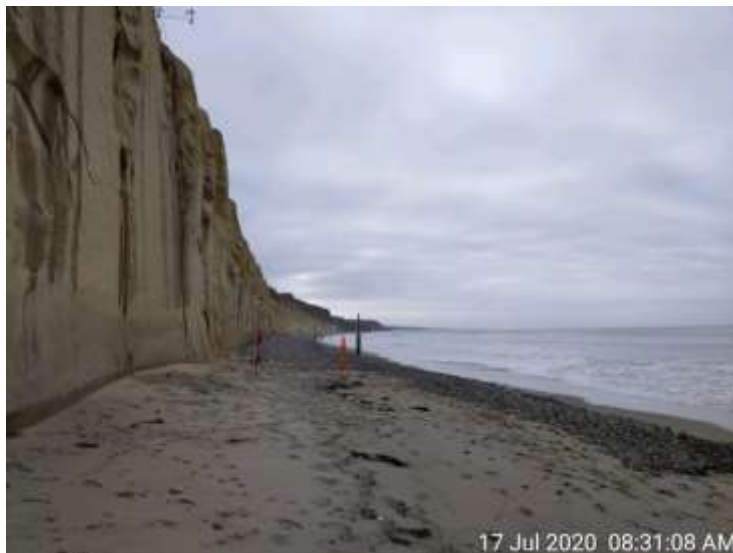
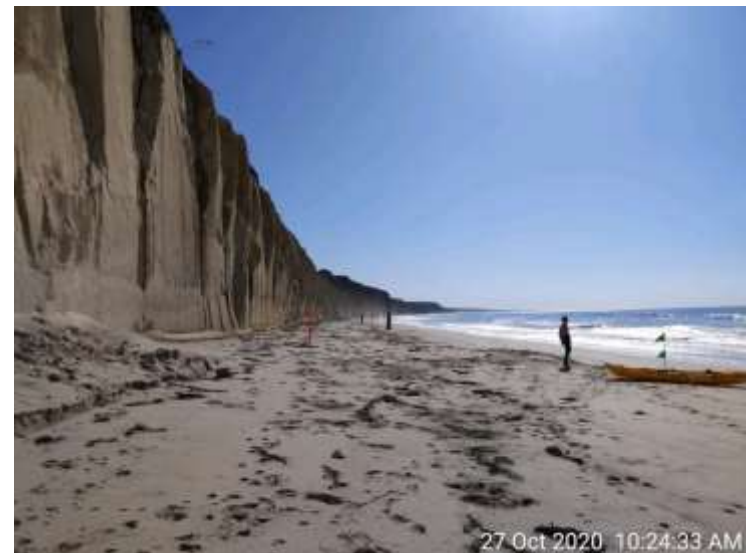
**Photo B-12. Photographs taken in February (top left), May (top right), July (bottom left), and October 2020 (bottom right) looking south from range S0500.**

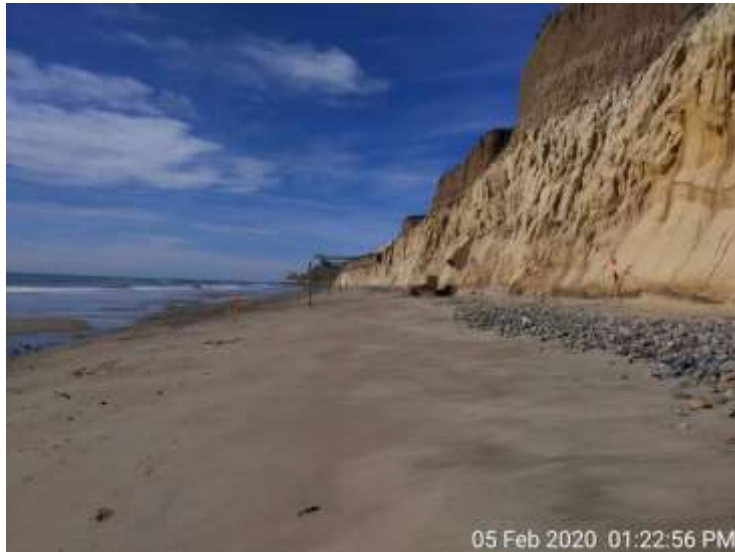
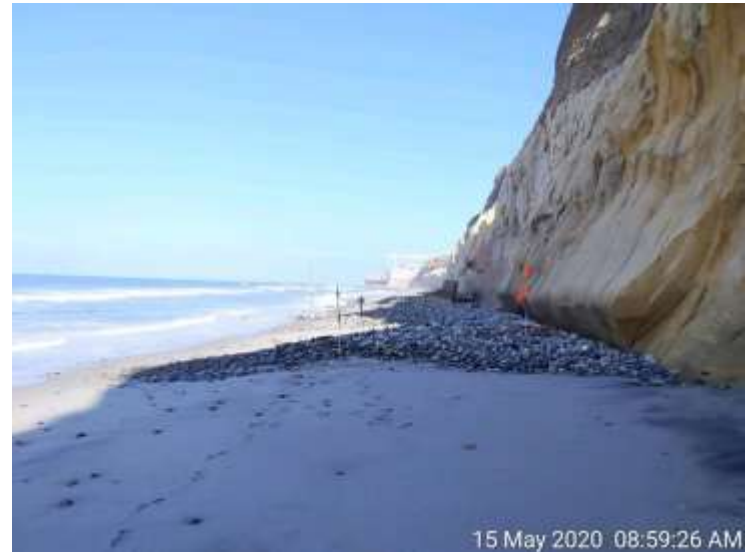
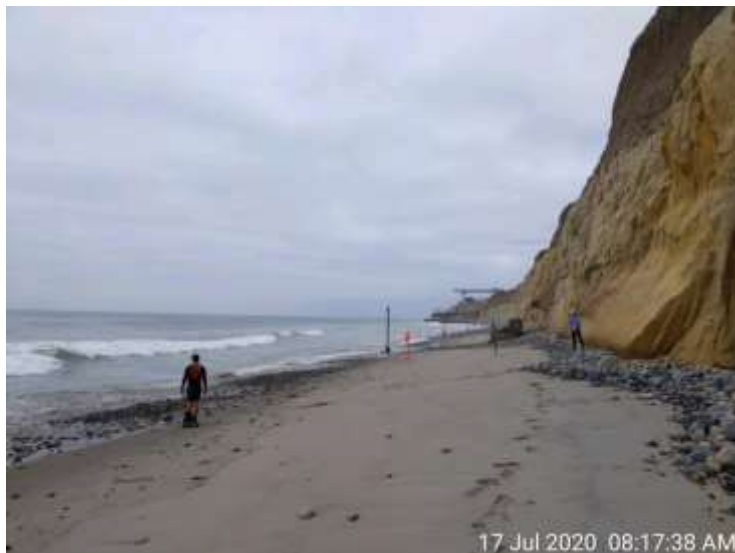
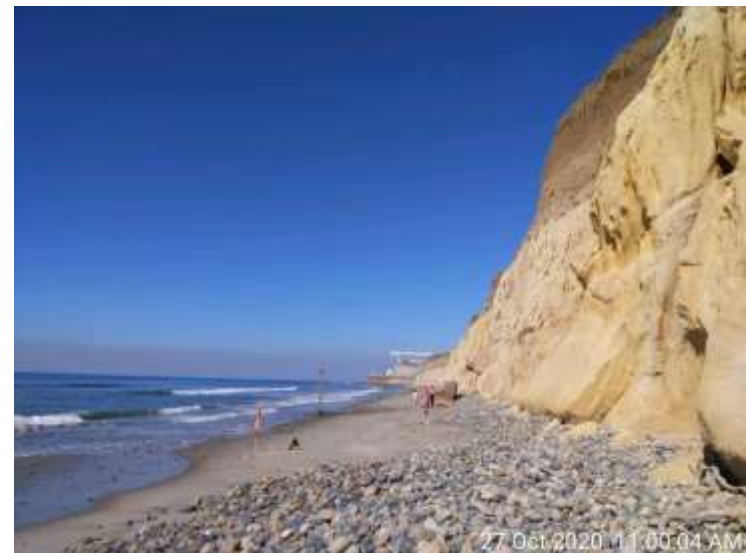
**Photo B-13. Photographs taken in February (top left), May (top right), July (bottom left), and October 2020 (bottom right) looking north from range S1000.**

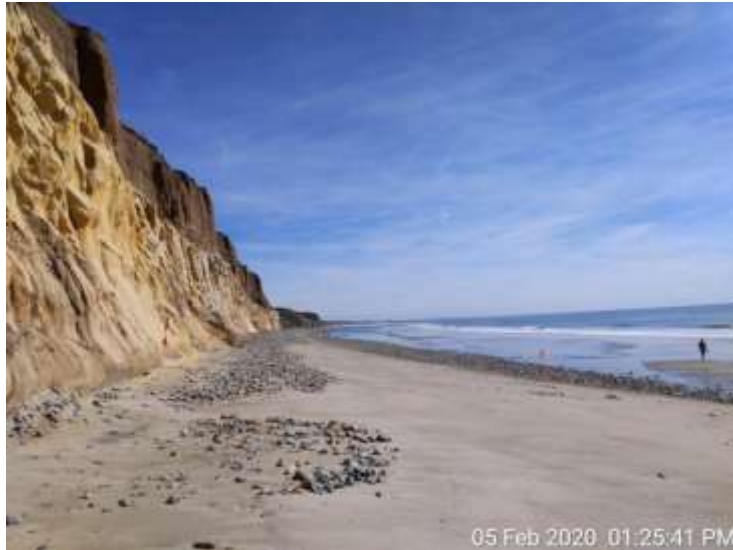
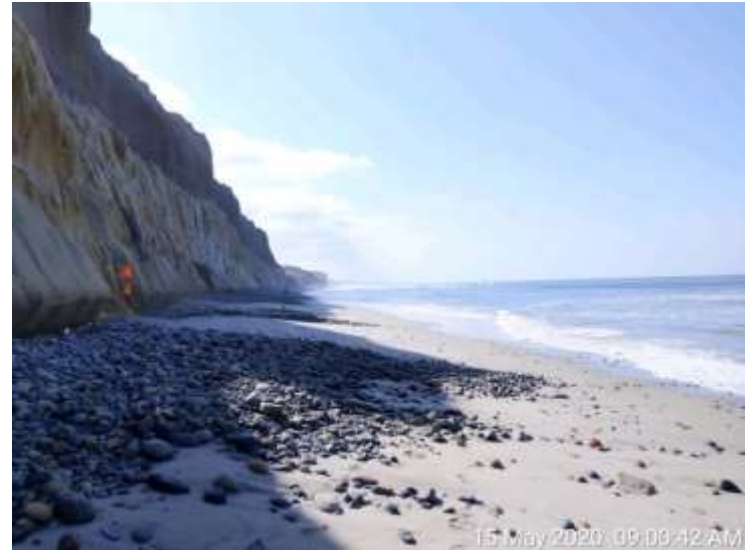
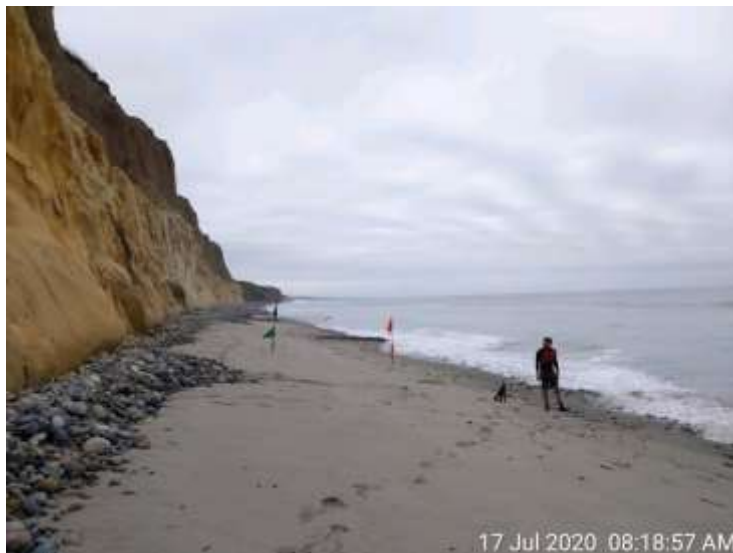
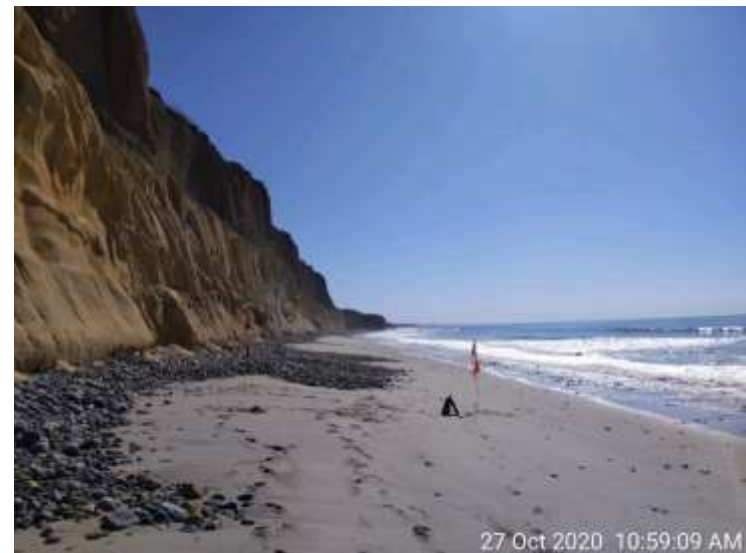
**Photo B-14. Photographs taken in February (top left), May (top right), July (bottom left), and October 2020 (bottom right) looking south from range S1000.**
