**SAN ONOFRE NUCLEAR GENERATING STATION (SONGS)  
SONGS MEAN SEA LEVEL RISE IMPACT ASSESSMENT**

**Technical Report for  
CSLC Special Provision 14 in Lease No. PRC 6785.1**

CE Reference No. 21-07  
25 March 2021

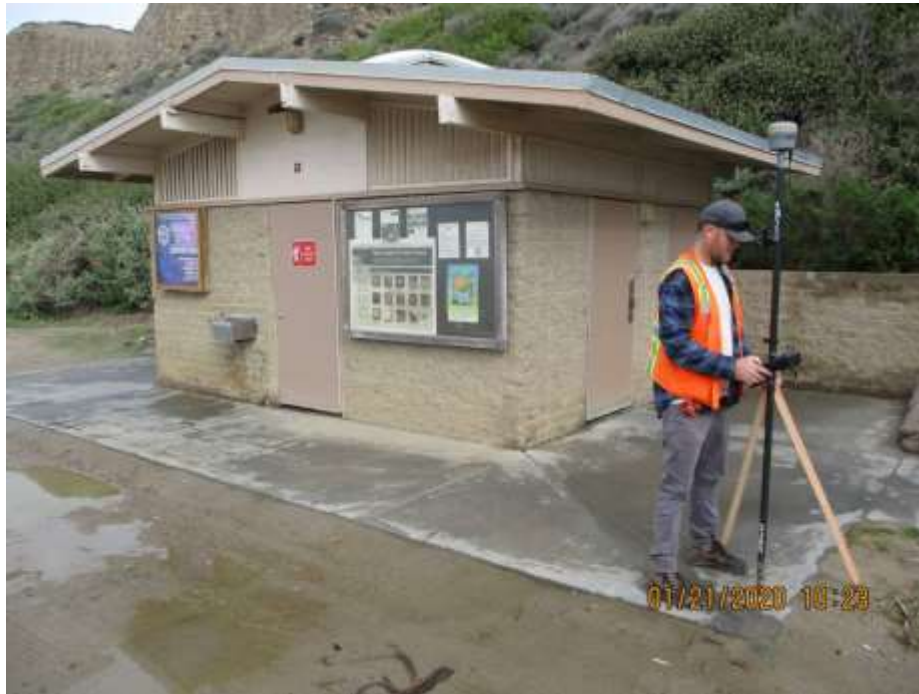
**Photo B-15. Benchmark BM04, created on 21 January 2020, is located on the SW corner of Bathroom 4 in the San Onofre State Beach parking lot.**

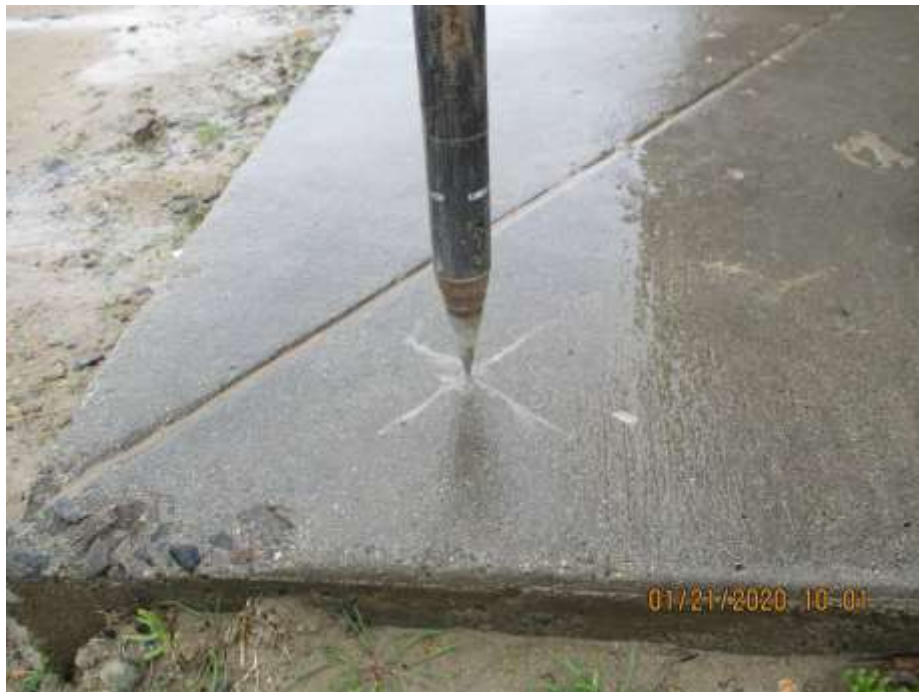
**Photo B-16. Benchmark BM02, created on 21 January 2020, is located on the SW corner of Bathroom 2 in the San Onofre State Beach parking lot. Benchmarks BM02 through BM06 are all marked by a scribed X on the concrete foundation.**

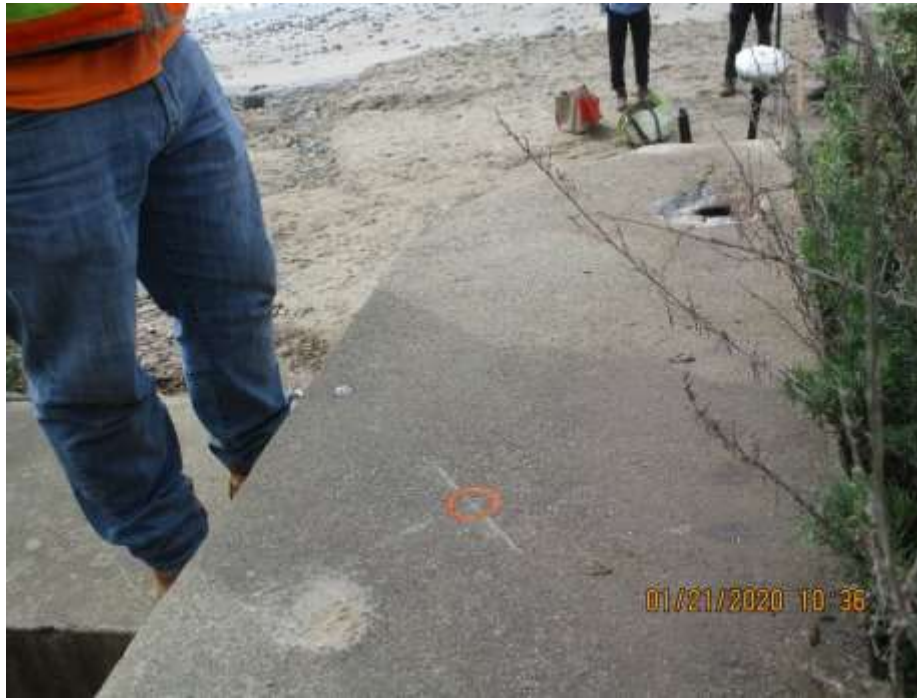
**Photo B-17.** Benchmark BM07, created on 21 January 2020, is located on the NE corner of a concrete structure located south of the San Onofre State Beach parking lot and north of transect N0500.

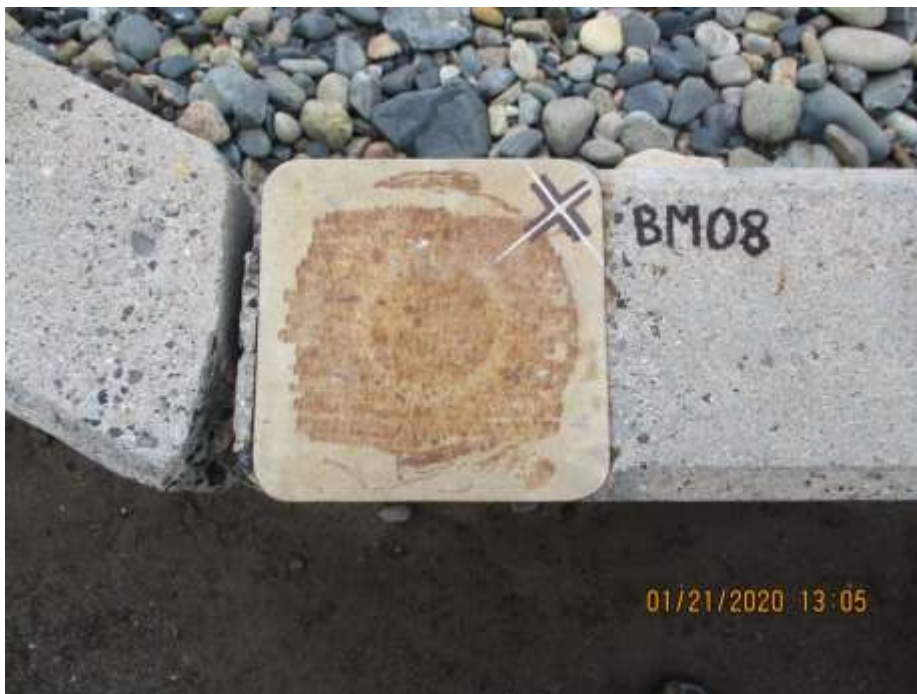
**Photo B-18.** Benchmark BM08, created on 21 January 2020, is marked by a scribed X and located just south of transect NS0000 on top of the seawall.

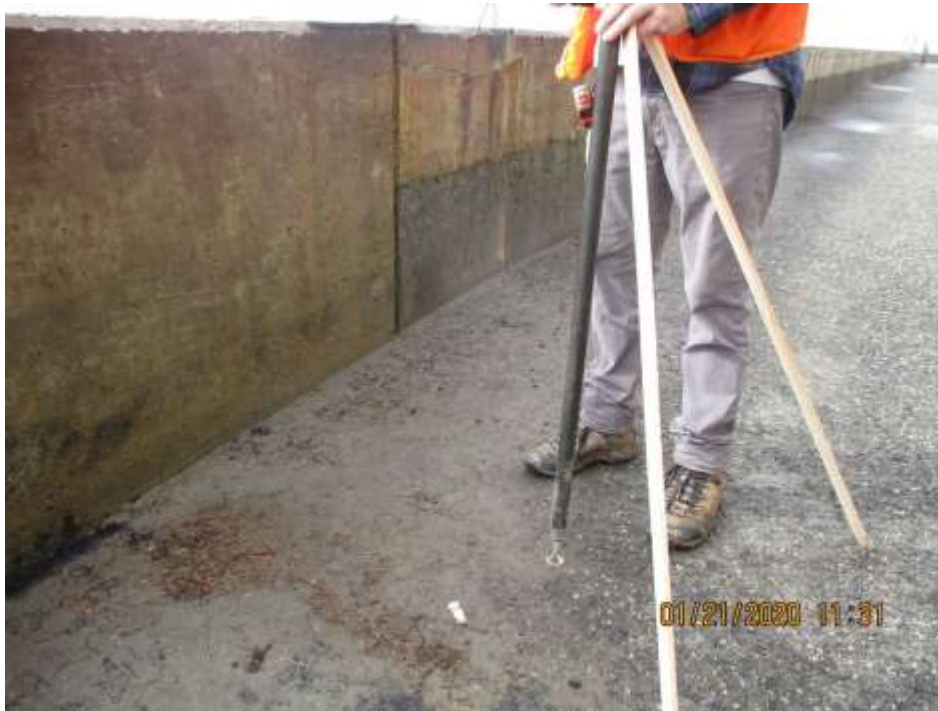
**Photo B-20.** Benchmark BM10, created on 21 January 2020, is marked by a metal screw and washer and is located on the walkway south of transect S0800'. This benchmark has replaced benchmark 2051613.

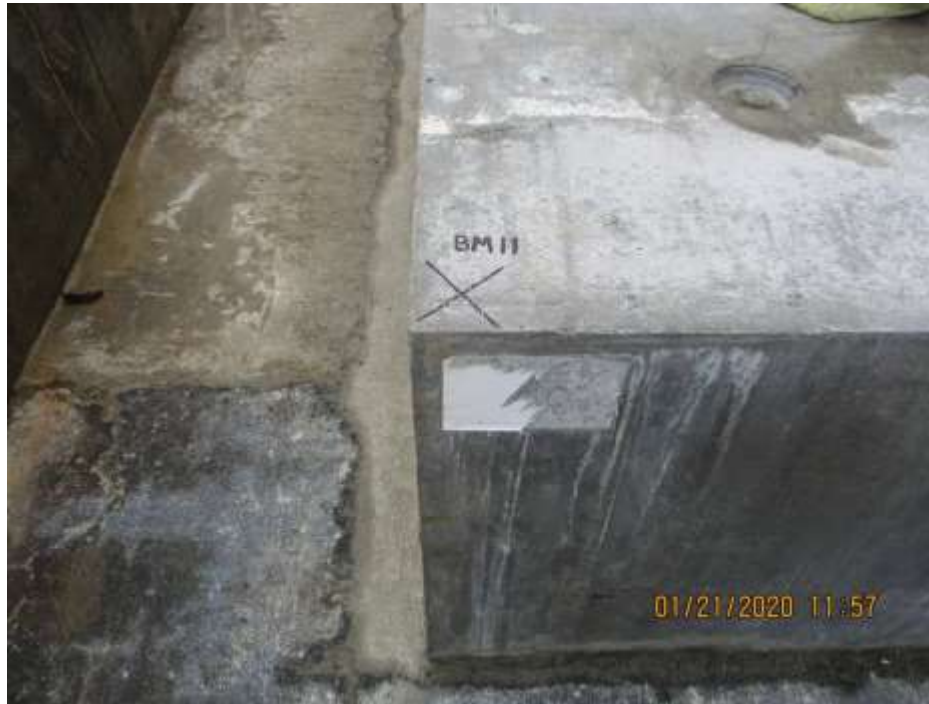
**Photo B-21. Benchmark BM11, created on 21 January 2020, is located on top of the concrete blocks at the southern end of the SONGS walkway.**

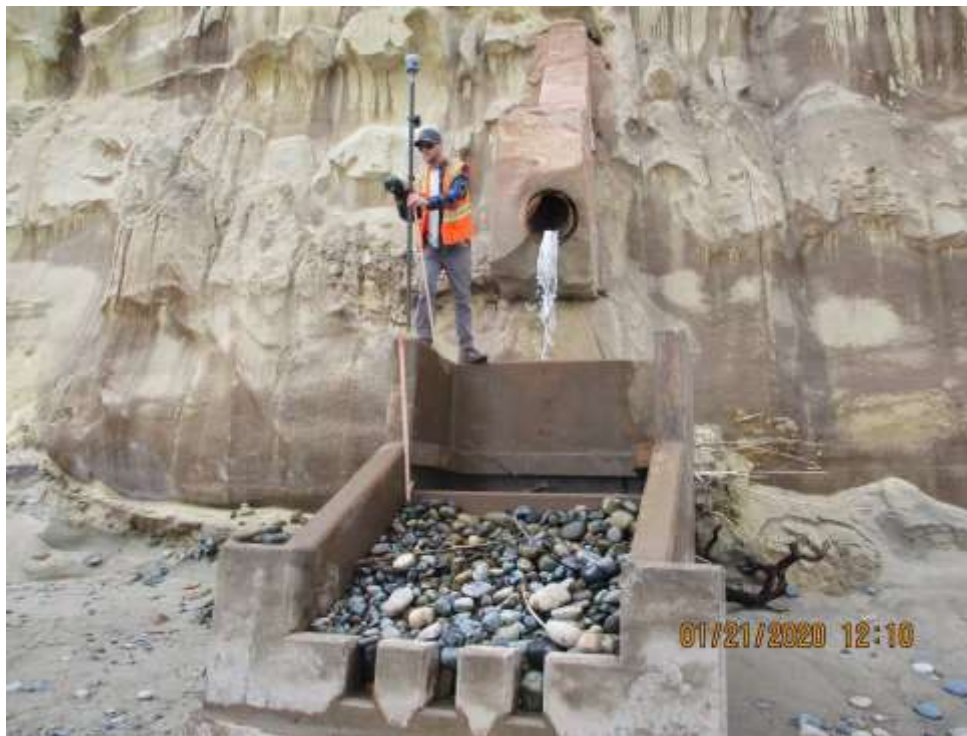
**Photo B-22. Benchmark BM12, created on 21 January 2020, is located on top of the concrete drainage structure located just north of transect S1000.**

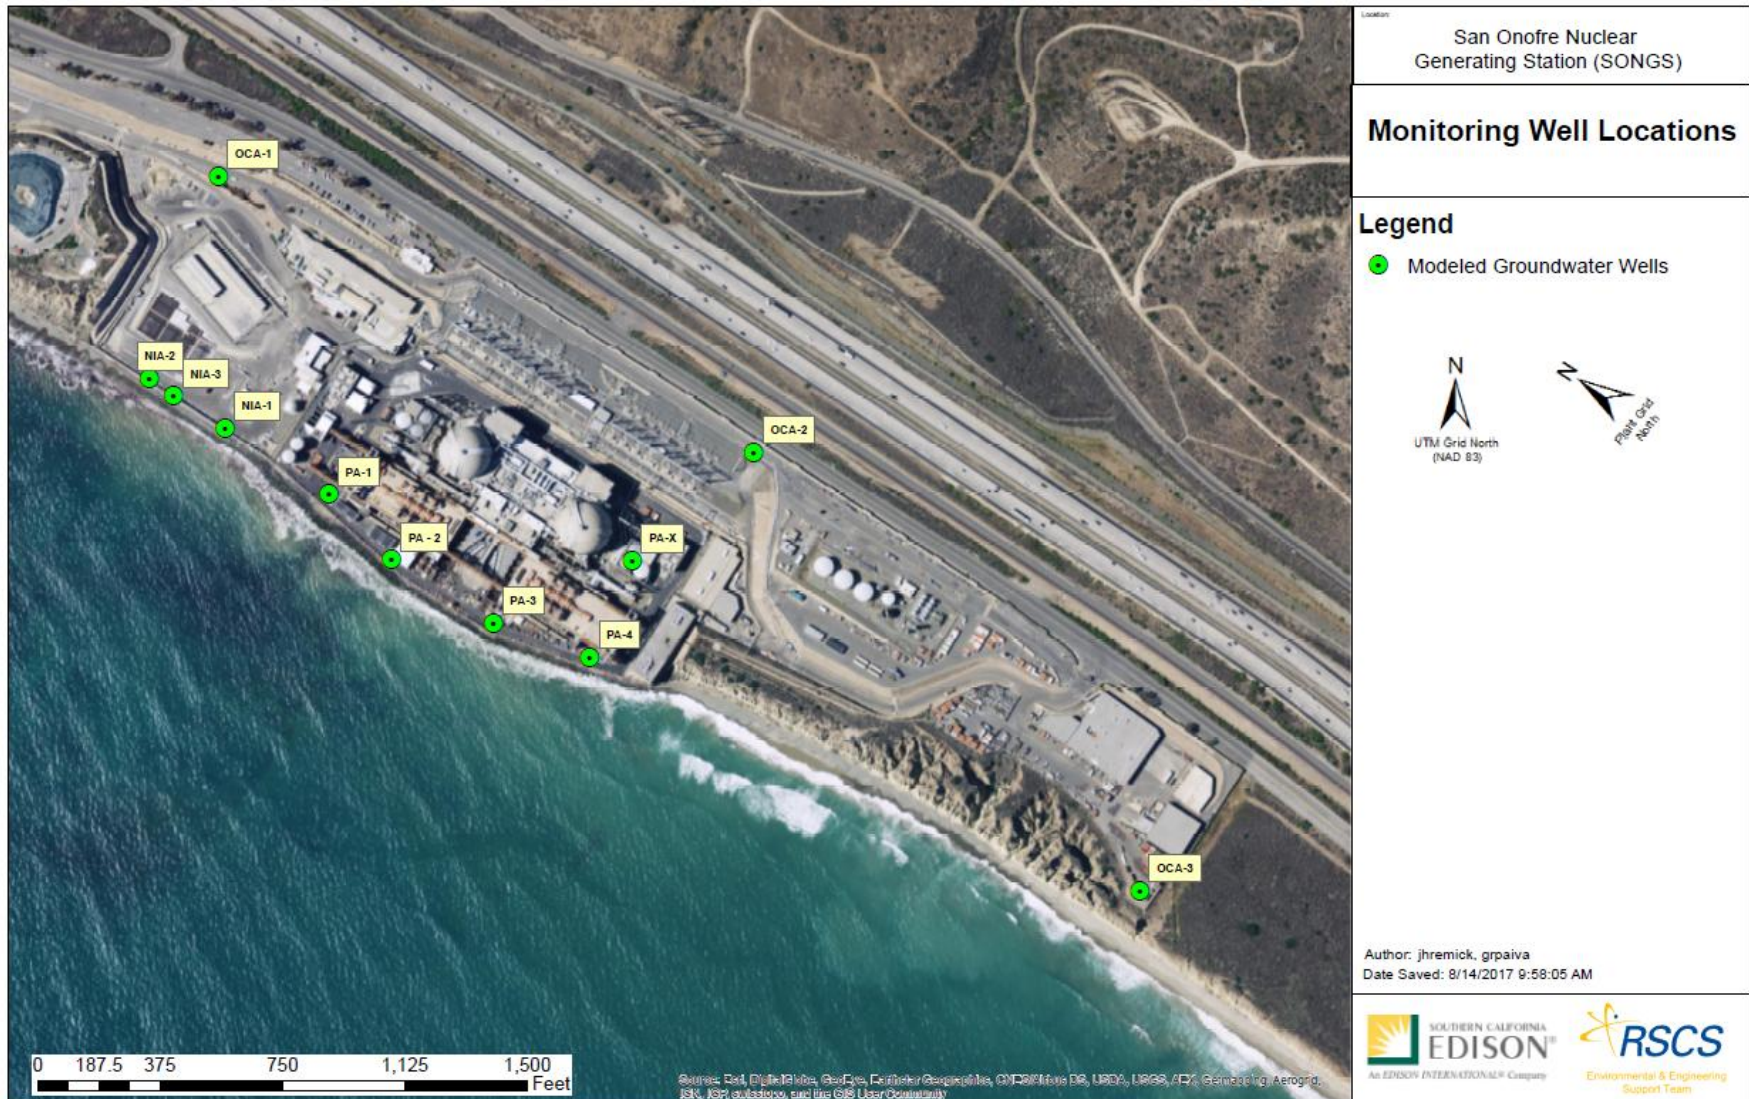
**Figure 2-1. Locations of SONGS groundwater wells.**

To better examine groundwater trends, each of the 16 wells was assigned to one of three groups based on their elevation and location within SONGS. Group 1 includes wells NIA-1, NIA-2, NIA-3, NIA-4, NIA-5, NIA-6, NIA-7, NIA-10, and NIA-11. This clustered group of wells occupies the lowest ground surface elevation and is located between the shoreline and North Industrial Area (Unit 1 remnants and ISFSI). Group 2 includes wells PA-1, PA-2, PA-3, and PA-4, which are at middling ground surface elevations and located between Unit 2/3 structures and the shoreline. Group 3 includes the remaining wells OCA-1, OCA-2, and OCA-3, which have the highest ground surface elevations and lie farthest from the shoreline.
