# Decommissioning San Onofre

Nuclear Generating Station

## Canister Downloading

- Incident Review
- Path Forward

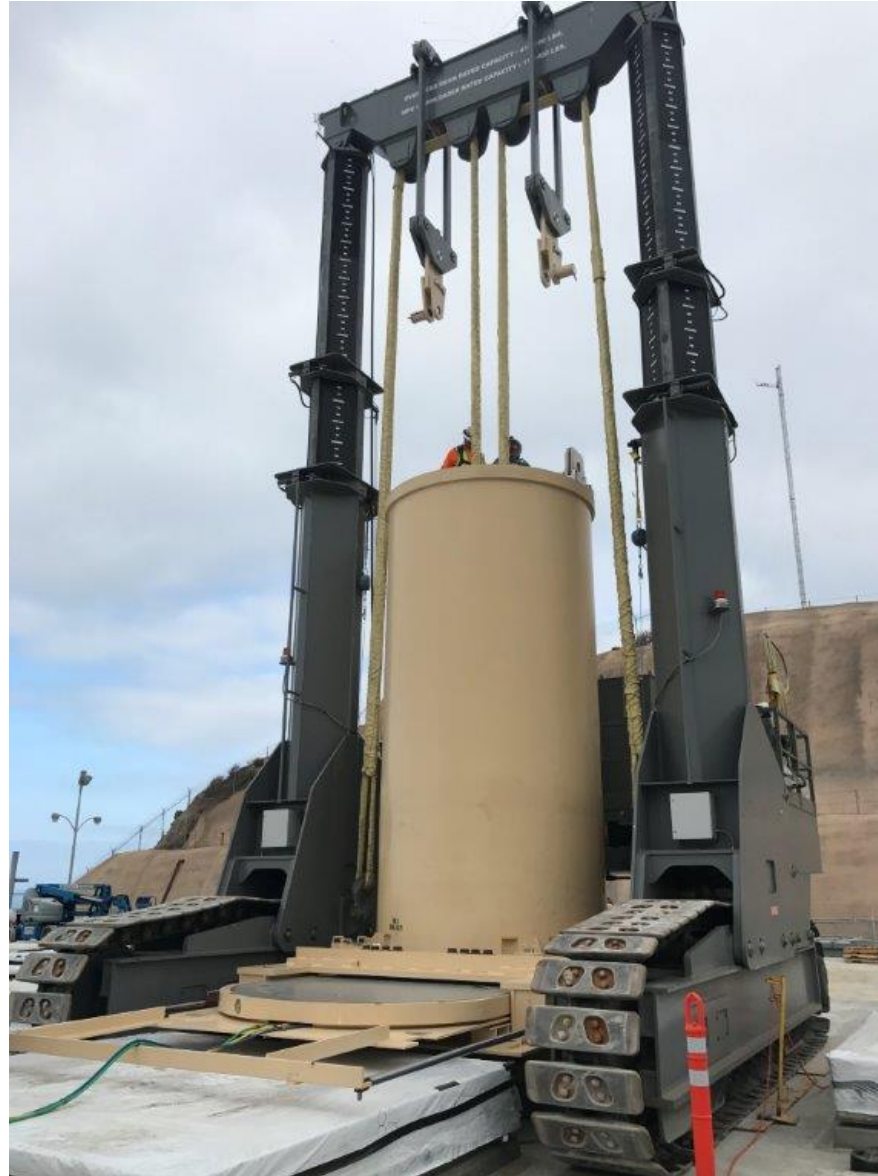
- Canister #29 wedged on shield ring during download
  - Not supported by rigging, not initially recognized by crew
- Canister safely lowered into final storage position
- Canister analyzed for drop greater than 18 feet and remain intact
- SCE halted work to investigate
- NRC briefed on Aug. 6
- No risk to public health & safety

# What happened on Aug 3

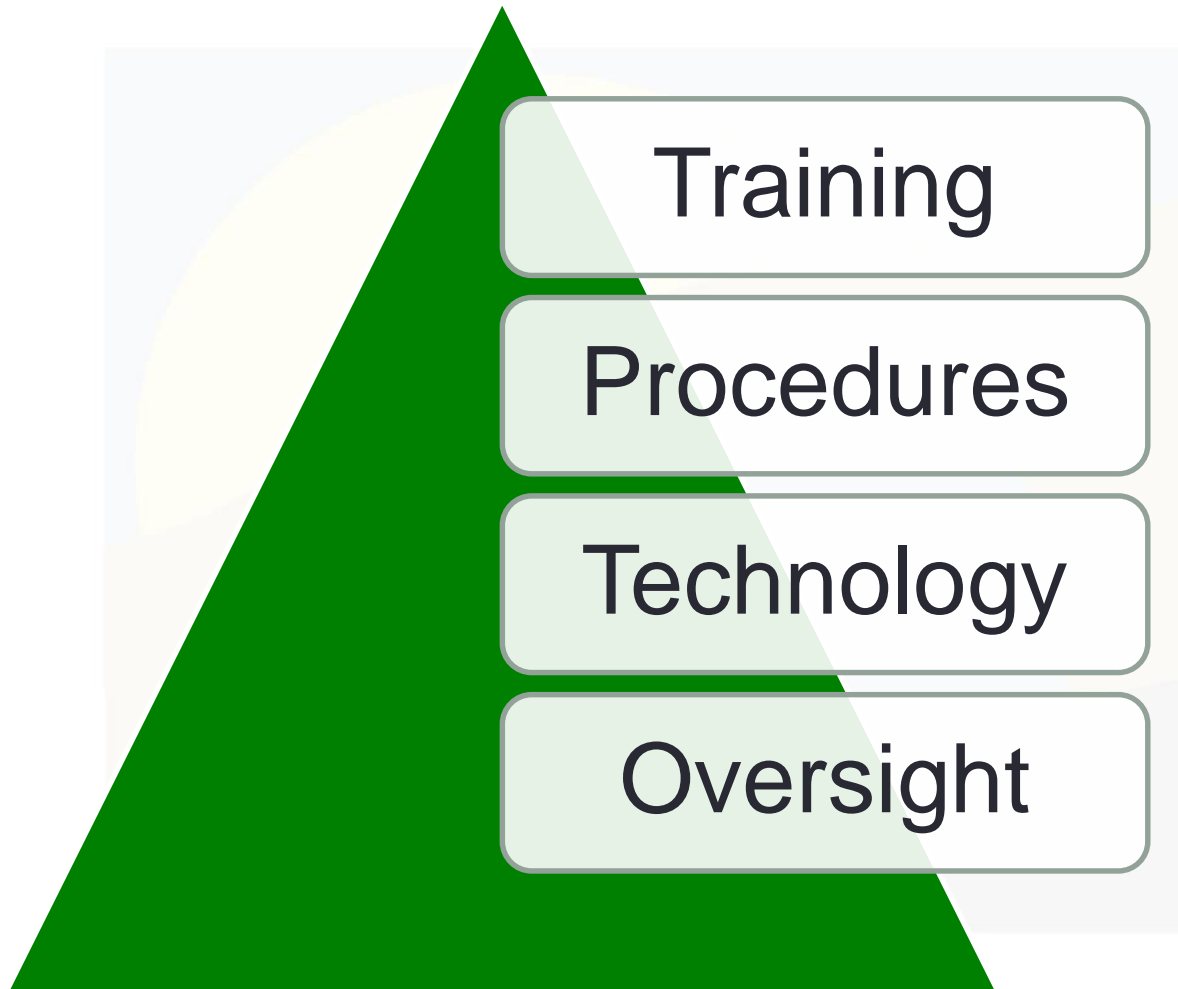
# What causes were identified

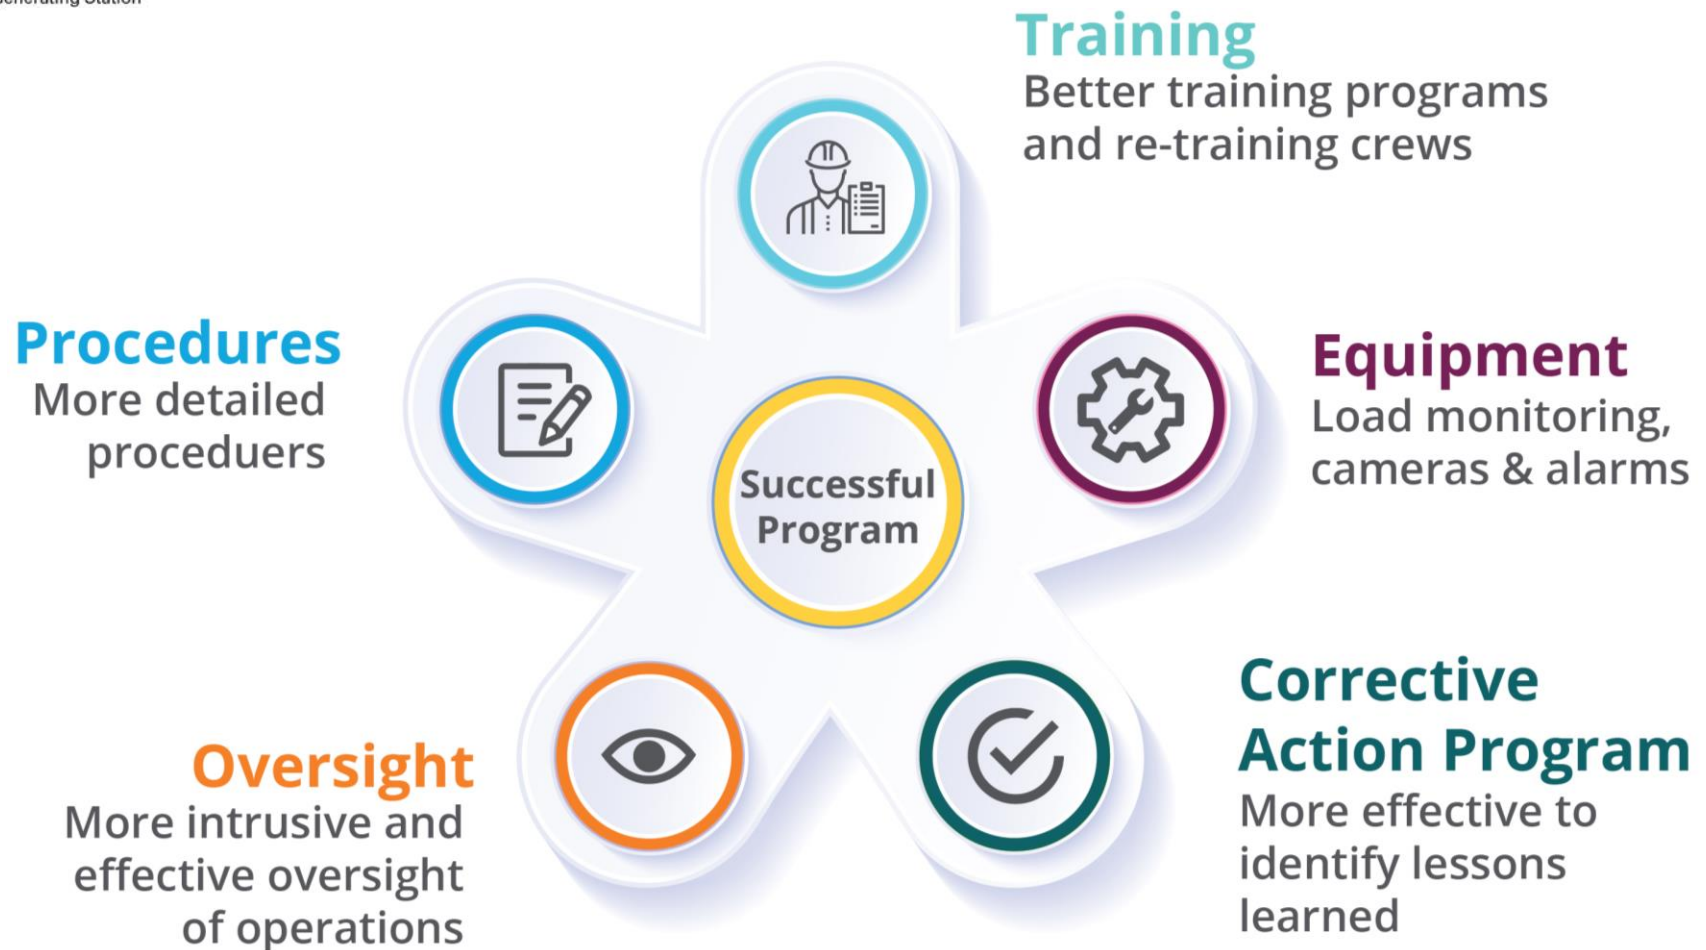
# What is being done to prevent reoccurrence?

Program Element	Actions
Enhanced Training & Procedures	<ul style="list-style-type: none"><li>• More specific training</li><li>• More detailed procedures</li><li>• Revised downloading alignment &amp; multiple observers</li></ul>
Improved Load Monitoring	<ul style="list-style-type: none"><li>• Independent and redundant features to verify load</li><li>• Telltale monitoring, camera indications &amp; alarms</li></ul>
Enhanced Oversight	<ul style="list-style-type: none"><li>• Additional SCE staff with Holtec downloading experience</li><li>• More specific training for SCE oversight team</li></ul>
Re-Training Crews	<ul style="list-style-type: none"><li>• New procedures and load monitoring</li><li>• More detailed training for new staff</li></ul>
Independent Assessment Team	<ul style="list-style-type: none"><li>• Assess procedures, equipment, training &amp; practice runs</li></ul>
Performing Practice Runs	<ul style="list-style-type: none"><li>• Validate new procedures, training &amp; load monitoring</li><li>• Oversight by Independent Readiness Assessment Team</li></ul>
